TREE INVENTORY

Prepared for
LEISURE WORLD MUTUAL 10
SEAL BEACH

Prepared by
JAMES KOMEN – CLASS ONE ARBORICULTURE
ISA CERTIFICATION #WE-9909A
(818)495-5344
CLASSONEARBORICULTURE@GMAIL.COM
DECEMBER 16, 2013

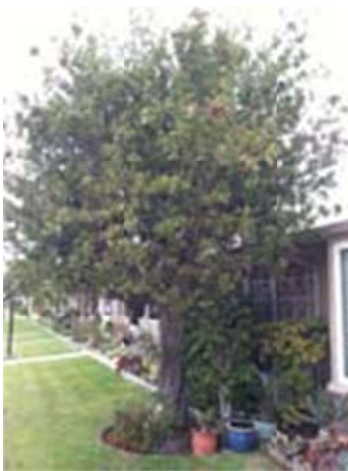
<p>Sites 1, 2, and 3 <i>Callistemon citrinus</i> - Lemon Bottlebrush</p> <p>These bottlebrush trees need to be pruned for roof and sidewalk clearance. They are planted a little bit too close to the building, and there may be problems with their roots causing damage to the patio eventually.</p> <p>Maintenance: 40 min. Next Service: now Priority: high</p>
 	<p>Site 4 <i>Lagerstroemia indica</i> - Crape Myrtle</p> <p>The stakes on this Crape Myrtle need to be removed immediately. The ties are creating constriction points that are damaging the bark. The stakes themselves are leaving abrasion marks on some of the upper branches. If the tree cannot stand on its own, then it can be re-staked with the new stakes placed further apart, outside the root ball.</p> <p>The trunk of this tree has a kink that was caused by aggressive tying in the nursery before the tree was purchased. This deformation will limit the tree's lifespan, but it can be retained because the tree does not pose a hazard to the landscape at this time. It should be maintained for roof and sidewalk clearance.</p> <p>Maintenance: 20 min. Next Service: now Priority: high</p>

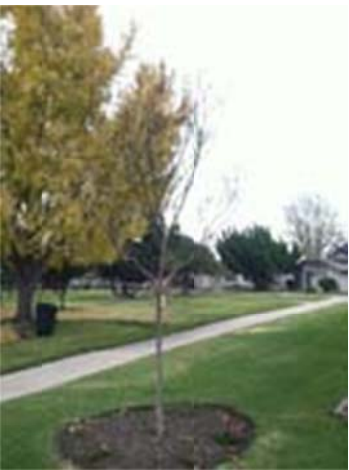
<p>Site 16 <i>Lagerstroemia indica</i> - Crape Myrtle</p> <p>This Crape Myrtle was well-chosen for the site. It should be monitored for roof and sidewalk clearance as it grows older. There is evidence of soil disturbance around the base of the tree for planting of flowers. Shareholders should be reminded that there should not be digging around the root crown of a tree because it will damage roots and harm the long-term health of the tree.</p> <p>Maintenance: zero Next Service: fall Priority: low</p>

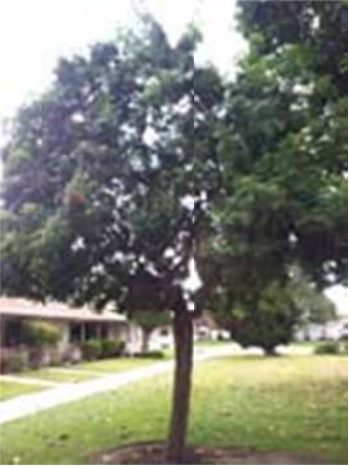
<p>Site 21 <i>Schinus terebinthifolius</i> - Brazilian Pepper</p> <p>This young tree just needs a bit of interior deadwood cleaning. It is a fast-growing species that will need to be maintained for head height clearance every 6 to 12 months. The trunk of this tree is severely deformed and this will limit the ultimate lifespan of the tree. For now, it can be retained as an oddity in the landscape.</p> <p>There are stress cracks along the Southern side of the trunk. These cracks should be monitored. If they grow and the bark loss advances, then the tree may have to be removed. For now, the tree does not pose a hazard and can be retained.</p> <p>Maintenance: 20 min. Next Service: spring Priority: medium</p>

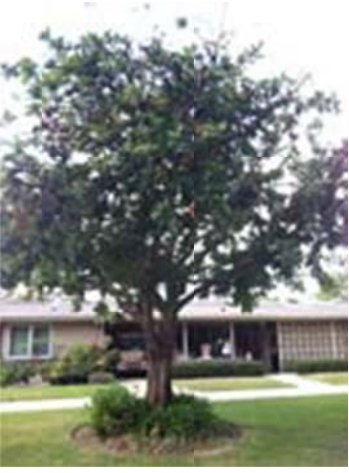
<p>Sites 27 <i>Ceratonia siliqua</i> - Carob Tree</p> <p>This Carob Tree has some severe squirrel chew damage on many of its branches. The squirrel chew wound sites have girdled the stem of some of the branches that have subsequently died back. Aesthetically, the deadwood can be removed from the tree. The tree should also be pruned for head height clearance.</p> <p>Maintenance: 20 min. Next Service: now Priority: medium</p>

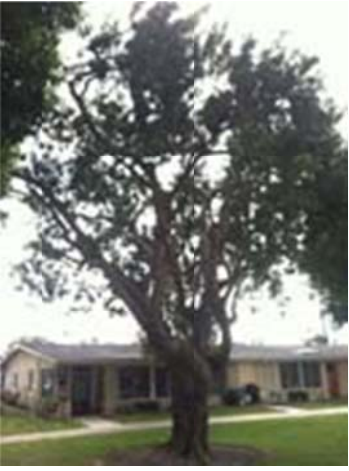
<p>Site 28 <i>Schinus terebinthifolius</i> - Brazilian Pepper</p> <p>This pepper tree is growing in competition with the neighboring rubber tree, and it should be pruned back to make way for the rubber tree. In the past, many of its branches have been severely headed back, and these wound sites are apparent. Too much of the live foliage was removed from this tree, so it is currently in a stressed condition.</p> <p>Maintenance: 40 min. Next service: spring Priority: medium</p>

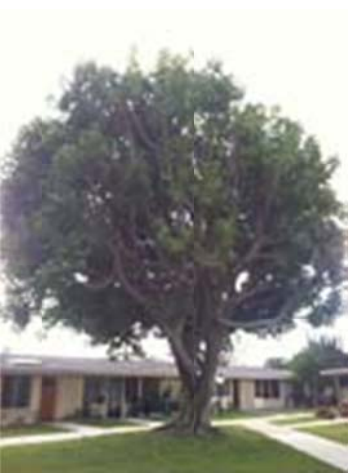
<p>Site 29 <i>Ficus elastica</i> - Rubber Tree</p> <p><i>Ficus</i> trees are jungle-giant monsters. They have aggressive roots that can lift and buckle foundations and pavement.</p> <p>In the past, the sidewalk around this tree was replaced, and a root barrier was installed along the border of the sidewalk. This appears to have held back the advance of the roots for now, but because it is so close to the sidewalk, there is still a very good likelihood that this tree will continue to grow new roots under it.</p> <p>This tree is a fast-growing species that will need to be maintained often to be retained in the landscape. Fringe at the tips should be thinned and reduced back to subordinate branches that are capable of assuming apical dominance. The tree should not be tipped or topped because that will cause long-term structural problems.</p> <p>Maintenance: four hours with climber Next Service: spring Priority: medium</p>

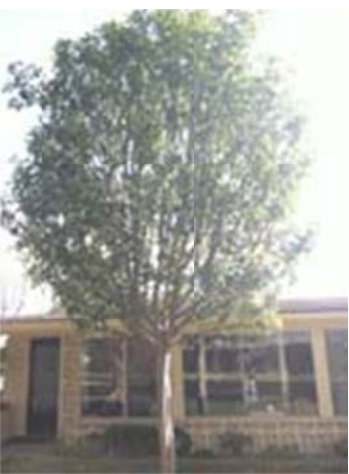
<p>Site 30 <i>Prunus spp.</i> - Ornamental Plum</p> <p>This ornamental plum has problems that originated at the nursery. It has many shoots all originating at the same point on the trunk, making them susceptible to wind throw and tearout. They can be corrected by gradually removing one of the competing shoots each year for 2 to 3 years until the tree is trained back into a strong structure. If they are not pruned back, then the branches will grow in girth and the bark will press up against itself creating a site that can harbor disease and decay.</p> <p>The tree should be maintained for roof and sidewalk clearance</p> <p>Maintenance: 10 min. Next Service: spring Priority: medium</p>

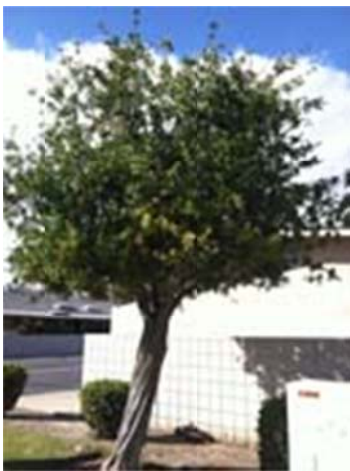
<p>Site 34 <i>Juniperus chinensis</i> - Hollywood Juniper</p> <p>This Hollywood Juniper is a good choice of species because it requires little maintenance. Unfortunately, its planting site is very small, and it appears to have already sustained some root damage. There are some cavities in the root crown on the northern side of the trunk that should be monitored. If decay advances much more into these cavities, then the tree will be a structural hazard and will need to be removed. There is a <i>Ficus</i> tree in a pot growing beneath this tree that should be moved before it competes with the canopy of the Juniper tree.</p> <p>Maintenance: 10 min. Next Service: fall Priority: medium</p>
 	<p>Site 35 <i>Callistemon citrinus</i> - Lemon Bottlebrush</p> <p>This bottlebrush tree is recovering from a severe pruning in the past. It only needs to be pruned for roof and sidewalk clearance at this time.</p> <p>Maintenance: 15 min. Next service: now Priority: high</p>

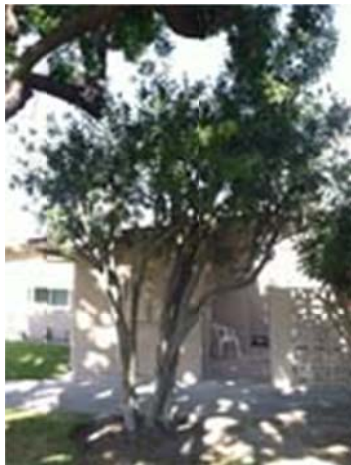
Site 37 and 39
Callistemon citrinus - Lemon Bottlebrush

These two bottlebrush trees were planted a bit too close to the building and the sidewalk, and they may cause problems by lifting the sidewalk with their roots in the future. They will also need to be maintained often to maintain building and sidewalk clearance. Lastly, they are in competition with the Oleander between them. If the Oleander is to be retained, then they should be pruned back to make space for it. If the Oleander is to be removed, then they can be allowed to grow together.

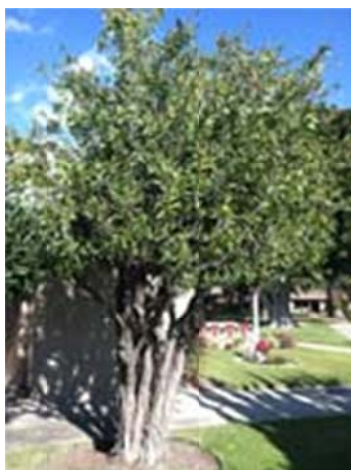
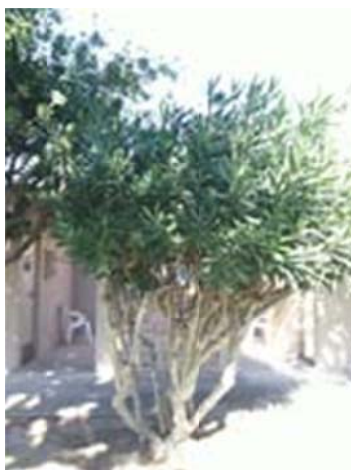
Site 38
Oleander nerium - Oleander

This is not actually a tree, but a bush pruned in a tree form. There are many trunks, all of which have been severely headed back in the past. Each of these stump wounds will become a site that will harbor decay in the future. There is some bark loss low on the root crown on some of the shoots, and these shoots may soon die back and need to be removed. This Oleander will not have a long lifespan in the site, but it can be retained until it becomes a nuisance or begins to die back.

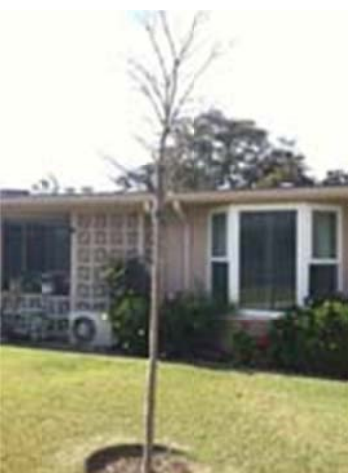
<p>Site 44 <i>Lagerstroemia indica</i> - Crape Myrtle</p> <p>This tree needs to be re-staked immediately. The ties are constricting the trunk of the tree and deforming it. A stake is pressed up against the trunk of the tree and is creating abrasion marks. These wounds will be retained by the tree for the rest of its life, and they will eventually become weak points in the trunk that may turn into failure sites later in the tree's life. If the tree cannot stand on its own after the stake is removed, then it should be re-staked properly by driving two stakes into the ground outside the root zone of the tree and attaching wire and hose tubing that allows the tree freedom to move in the wind. If the tree does not have freedom to move, it will not develop proper trunk taper that is necessary for it to be able to stand on its own. The constriction is so severe on the top tie that this wound site may ultimately be the determinant of the tree's lifespan. It is possible that it will die in the next 1 to 2 years and need to be replaced.</p> <p>Maintenance: 20 min. Next Service: now Priority: high</p>

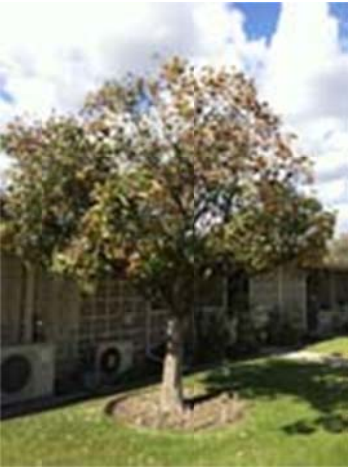
<p>Site 45 <i>Pittosporum undulatum</i> - Victorian box</p> <p>This Victorian box has been aggressively pruned in the past and should be allowed to recover. It will need to be pruned for roof clearance. There is one anomalous branch that is growing out to the Southwest that should be pruned back to the parent stem. This tree is fruiting very well, and there is a good possibility that it will recover from its aggressive pruning in the past.</p> <p>Maintenance: 15 min. Next Service: spring Priority: medium</p>

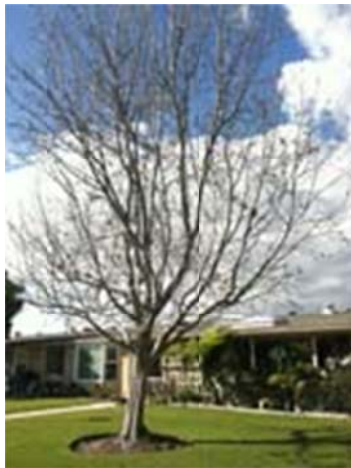
Site 49
Liquidambar styraciflua – Sweet Gum

This tree has some minor stress cracks on some of its branches that should be monitored. It is likely that it acquired these stress cracks from wind. If these stress cracks expand in size, then the affected branches may need to be removed before they become tearout hazards.

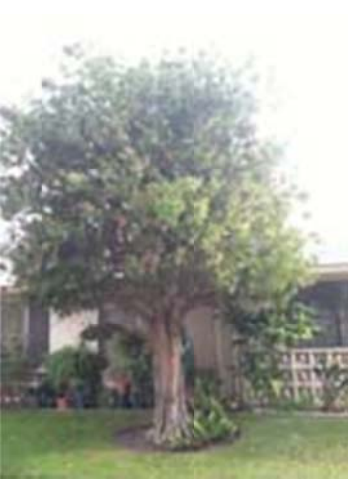
<p>Sites 1 and 2 <i>Callistemon citrinus</i> - Lemon Bottlebrush</p> <p>These trees are recovering from topping wounds from a few years ago. They need to be pruned for sidewalk and roof clearance.</p> <p>There are several hanging planters from the tree at site 1. Two of planters are hung correctly with hooks gently resting on the tops of the branches. One hanging planter and one garden hose mount are hung incorrectly with a wire girdling the branch. These hanging fixtures should be replaced correctly or removed entirely. If they are not corrected, then they will eventually cause abrasion wounds that will become entry points for disease and decay into the tree.</p> <p>The tree at site 2 has a large succulent plant growing at its base. Although there is concern that the succulent plant is competing with the tree for water, it is best to leave this succulent in place because it is protecting the trunk from mechanical injury.</p> <p>Maintenance: 30 min. Next Service: now Priority: high</p>

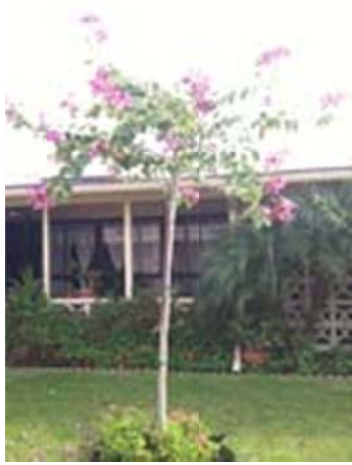
<p>Site 4 <i>Bauhinia x blakeana</i> - Hong Kong Orchid Tree</p> <p>This tree is very tightly tied to its planting stake. The stake and ties need to be removed immediately because they are causing damage to the trunk and restricting the flow of water and nutrients to the foliage. If the tree is unable to stand on its own, then it should be re-staked properly with two stakes driven into the ground outside the root ball of the tree. The trunk can be supported using wire and rubber tubing that allows the tree freedom of movement in the wind.</p> <p>This tree has also been topped, and a substantial stump has been left. The stump should be recut back to the next subordinate branch. Once this tree is re-staked, it should not be pruned for at least a year so that it can recover from its transplant shock and other stresses.</p> <p>Maintenance: 20 min. Next Service: now Priority: high</p>

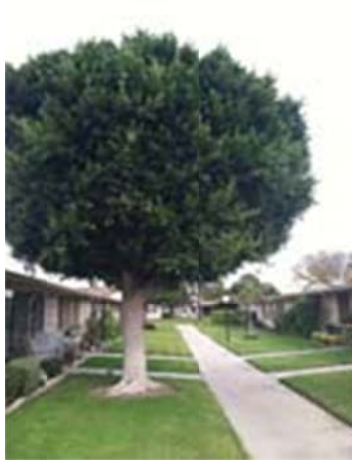
<p>Site 5 <i>Ficus microcarpa</i> - Indian Laurel Fig</p> <p>This was a poorly chosen species for the site because <i>Ficus</i> trees grow large quickly. They also have aggressive roots that can cause damage to foundations and hardscape. This tree will be especially destructive because it was planted in a small site and has an irrigation line running right through its root system. This tree will inevitably cause damage to the hardscape of the building to the North. There is already evidence of roots heaving the planter boxes in the private zone.</p> <p>This tree should be considered for removal, but if it is not in the budget this year, then it will need to be maintained heavily every year. It should be pruned for roof and sidewalk clearance.</p> <p>Maintenance: 60 min. Next Service: spring Priority: high</p> <p>Removal Recommended</p>

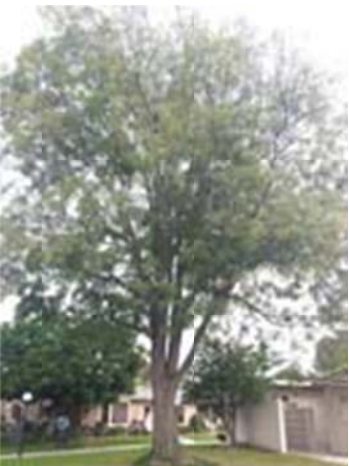
<p>Sites 10 <i>Fraxinus uhdei</i> - Shamel Ash</p> <p>This Shamel Ash needs a deadwood cleaning. There is significant deadwood in the canopy that should be removed before it self-prunes. It should be noted that ash trees grow very tall and this ash tree may grow another 20 to 30 feet. Ash trees should never be topped, so if height of this tree is a concern, then it should be reduced gradually over a period of 2 to 3 years. At this time, only deadwood removal is necessary, but after the next growing season, the fringe should be reduced.</p> <p>Maintenance: three hours with climber Next Service: now Priority: high</p>

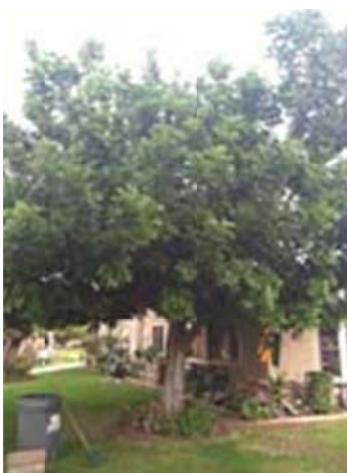
<p>Sites 12 <i>Cupaniopsis anacardioides</i> - Carrotwood</p> <p>This Carrotwood is very healthy and has a full canopy. It is showing signs of rapid growth, and it will need to be pruned for roof clearance. There are a few shoots that are growing a bit too long in the upper canopy, and they should be reduced back to subordinate branches that can assume apical dominance. This tree is also growing into competition with its neighbor Brazilian Pepper. The trees are approximately equal in growing potential and they can be allowed to compete with each other to create a full, dense canopy. The interior of the Carrotwood could be thinned a bit to reduce the growing potential of the tree.</p> <p>Maintenance: 30 min. Next Service: now Priority: high</p>

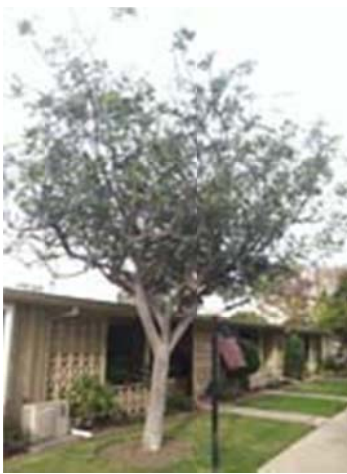
<p>Site 14 <i>Cupaniopsis anacardioides</i> - Carrotwood</p> <p>This Carrotwood is looking very sparse. It was heavily pruned in the past, and it appears to be suffering drought stress. Many of the leaves are cupping and curling, indicating that the tree is not getting enough water to its foliage. This could be due to low water, root damage, or a variety of other causes.</p> <p>From the pruning wounds, there are many shoots that have grown in response. They should be thinned to the strongest leaders to train the tree to a strong structure. If these training cuts are not made, then the shoots will be more susceptible to tear out in a windstorm. The tree should be monitored for roof and sidewalk clearance annually.</p> <p>Maintenance: 20 min. Next Service: spring Priority: medium</p>

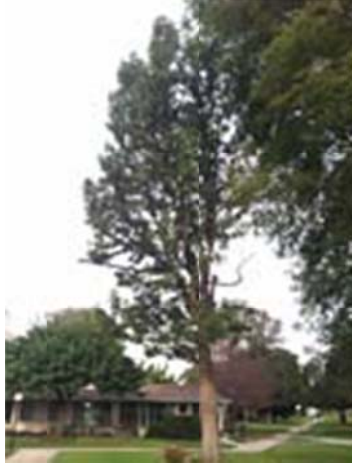
<p>Sites 21 <i>Grevillea robusta</i> - Silk Oak</p> <p>This Silk Oak is in heavy competition with its neighbor the Ash tree. It does not help that the southern side of the tree was heavily pruned back to make way for the Ash. There are many stumps on the southern side should be recut back to parent stems, and there is some deadwood that should be removed before it self-prunes. Further up the tree, there is some live foliage that is directly competing with the foliage on the fringe of the ash. Because of this competition, the tree has developed a slight lean to the North. Nearly all of its foliage is on the North side, and this is a predisposing factor for the tree to potentially fail to the North. It is not an imminent failure, but the tree should be monitored annually for any signs of stress. If such signs appear, then the tree should be removed and replaced before it becomes a hazard to the building to the North. For now, the stumps should be recut, the deadwood should be removed, and the competition should be addressed.</p> <p>Maintenance: two hours with climber Next Service: now Priority: high</p>

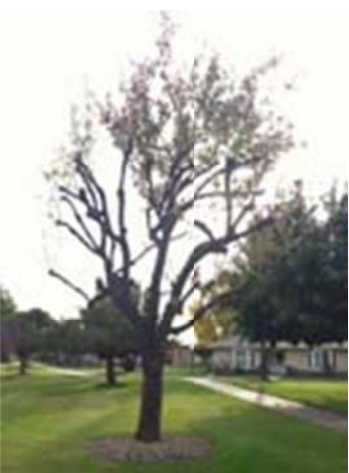
<p>Site 24 and 25 <i>Pyrus kawakamii</i> - Evergreen Pear</p> <p>These two pear trees were severely pruned in the recent past. The stump cuts that were left are barely resprouting. The trees have fire blight, which was likely acquired during the last pruning. As the fire blight claims live tissue, it can be removed by arborists who sterilize their tools between cuts. Eventually these trees will decline and die, but they can be retained for several more years.</p> <p>Maintenance: 40 min. Next Service: now Priority: low</p> <p>Removal Recommended</p>

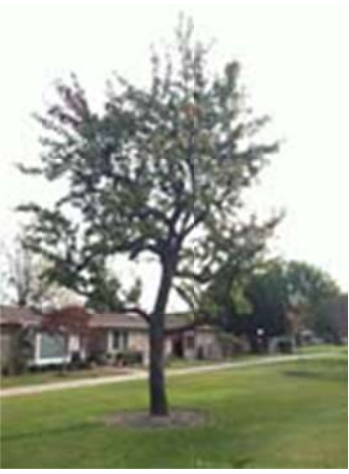
<p>Site 26 <i>Schinus terebinthifolius</i> - Brazilian Pepper</p> <p>This tree was aggressively pruned in the past and is currently in recovery mode. The foliage of the top of the canopy is looking a bit sparse. There are many stumps that remain from the previous pruning that should be cut back to the parent stems.</p> <p>Maintenance: 30 min. Next Service: winter Priority: medium</p>

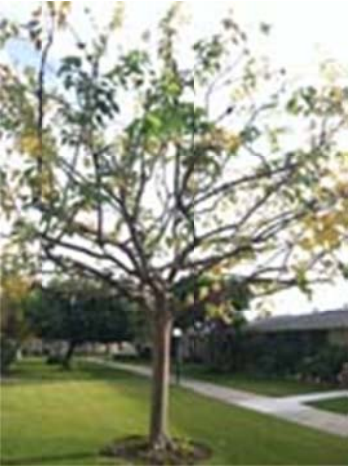
<p>Site 35 <i>Morus alba</i> - Fruitless Mulberry</p> <p>This young Mulberry tree has been tipped on nearly every one of its branches. The intention of this pruning was to keep it small, but instead it created wound sites that will serve as entry points for decay and disease. The tree will need some time to recover.</p> <p>Mulberry trees are fast-growing species, and they are known to grow up to 3 to 6 feet in a single growing season. This tree will be costly to maintain on an annual basis. In the fall, deadwood should be pruned out and the growing tips should be reduced back to subordinate branches that are capable of assuming apical dominance.</p> <p>Maintenance: 30 min. Next Service: fall Priority: high</p>

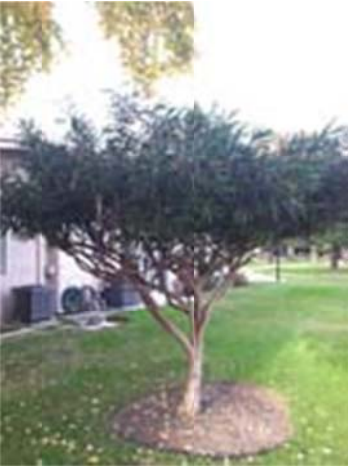
<p>Site 44 <i>Oleander nerium</i> - Oleander</p> <p>This Oleander is not actually a tree, but a bush that has been pruned into a tree form. The natural form of Oleander is a hedge or tall shrub. The stems have formed a chaotic structure, and it would be a waste of time to correct the defects in form. Rather, the Oleander should be allowed to grow in its anomalous form until it begins to decline and die. It likely has another five years left in the landscape.</p>

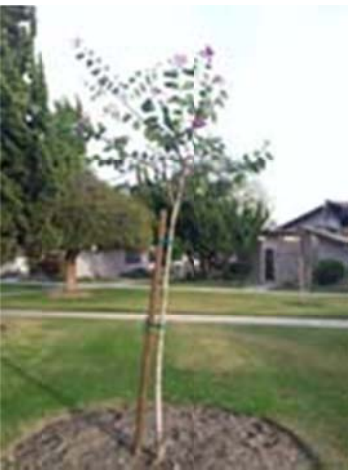
<p>Site 45 <i>Bauhinia x blakeana</i> - Hong Kong Orchid</p> <p>This tree needs to be re-staked immediately. The stake is too close to the trunk of the tree, and the ties are causing constriction and abrasion on the trunk. There are already some abrasion marks where the nursery stake was splinted up against the trunk of the tree. If this tree is not able to stand on its own, then it should be re-staked with 2 stakes, wire, and rubber tubing that allow it to sway freely in the wind. The tree needs to sway in the wind to develop trunk taper. There is some minor deadwood that can be cleaned out for aesthetic purposes.</p> <p>Maintenance: 20 min. Next Service: now Priority: high</p>

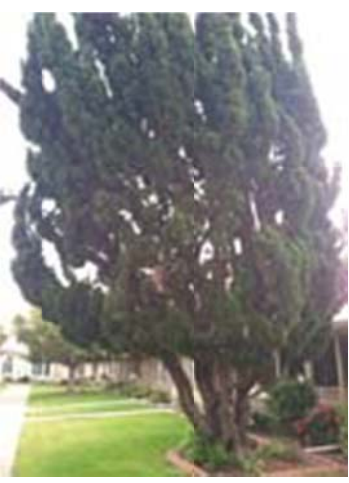
<p>Site 52 <i>Juniper chinensis</i> - Hollywood Juniper</p> <p>This Juniper tree is a good selection for the landscape because it is low maintenance. The interior deadwood has already been cleaned out and does not need to be cleaned for another 2 to 5 years. There are a few stump cuts that should be returned to the parent stem.</p> <p>This tree was planted with an irrigation line running very close to its trunk. It is possible that the roots of this tree will cause damage to the irrigation system or maintenance crews for the irrigation system will cause damage to the roots of the tree.</p> <p>Maintenance: 20 min. Next Service: now Priority: low</p>

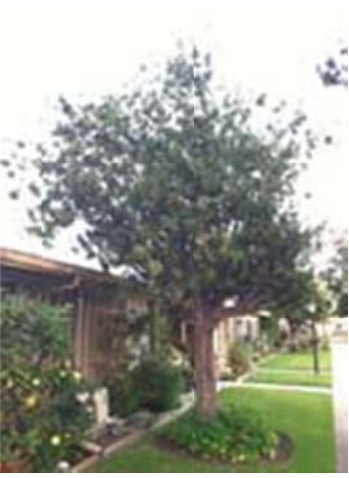
<p>Site 60 <i>Callistemon citrinus</i> - Lemon Bottlebrush</p> <p>This bottlebrush was planted a bit too close to the building, and its roots may cause some damage to the infrastructure. There appears to be a cavity on the Eastern and Northern sides of this tree that should be monitored annually. If fungal blooms appear, then the tree may need to be removed. Currently, the tree needs to be maintained for roof and sidewalk clearance.</p> <p>Maintenance: 15 min. Next Service: now Priority: medium</p>

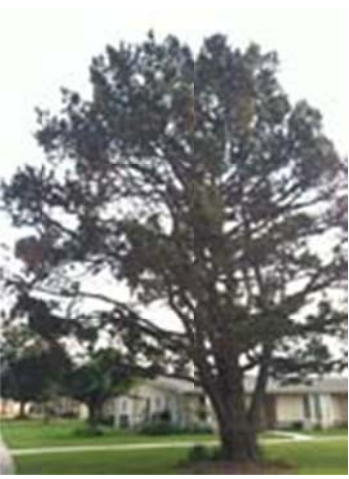
<p>Site 61 <i>Pinus radiata</i> – Monterey Pine</p> <p>This pine tree is suffering from an unknown cause. There are some weeping sites up and down the trunk and a long history of dried sap. These weeping sites are indicative of a pine borer infestation that can ultimately cause the death of the tree. This tree should be carefully monitored for signs of decline. Many of these weeping sites are dry which means that they have not been active recently. This is a good sign, and perhaps the tree has a chance to recover.</p> <p>The foliage is acceptable, but the lower foliage should be sprayed with water to knock out the dead needles and improve sunlight penetration. There is some minor deadwood that could be pruned out of the tree for aesthetic purposes.</p> <p>Little pruning needs to be done at this time because the tree needs a chance to cope with its stress.</p> <p>Maintenance: 30 min. Next Service: now Priority: low</p>

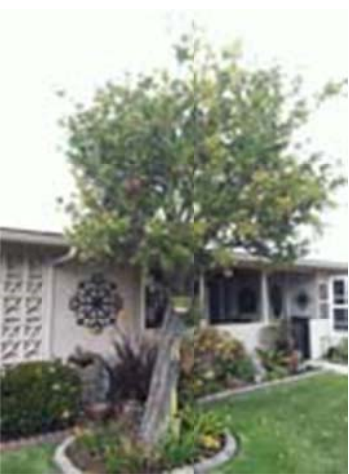
<p>Site 81 <i>Callistemon citrinus</i> - Lemon Bottlebrush</p> <p>This tree, like its neighbors, was pruned aggressively into a ball. It is currently in guarded condition, and not much live foliage should be removed at this time. Only a few cuts should be made for roof clearance. The leaves are beginning to yellow out, showing signs of stress. If the tree does not push out enough new foliage in the spring, then it may suffer decline in the summertime.</p> <p>There are several hanging planters in the tree that are hung from nails that are driven into the limbs. Driving nails into a tree limb creates a wound site that harbors decay and disease. Though this cannot be corrected at this time, it should be noted that nails should never be driven into live tree trunks or branches.</p> <p>Maintenance: 10 min. Next Service: spring Priority: medium</p>

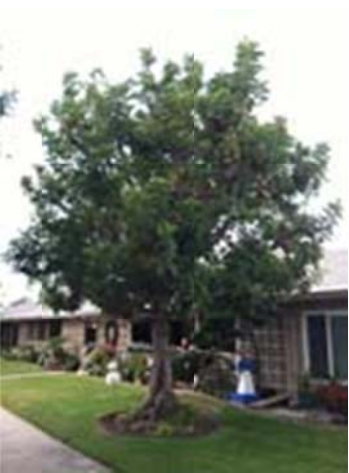
<p>Site 86 <i>Ceratonia siliqua</i> - Carob Tree</p> <p>This Carob Tree is causing damage to the adjacent building's patio and foundation. The Carob Tree is known to have medium aggressive roots and was not the ideal choice of species for the site. It was also planted very close to the irrigation line that is running right through its root crown. This tree will either damage the irrigation line or be damaged by maintenance crews fixing the irrigation line.</p> <p>This tree was maintained in the past by pruning heavily, and the foliage is looking sparse. It should be allowed to grow for a season to recover from its heavy pruning. It should be monitored for roof and sidewalk clearance. If construction work is done to fix the infrastructure of the adjacent building, then this would be a good opportunity to remove and replace the tree with one that is less root-aggressive. The homeowner living in the adjacent unit requests to keep the tree in the landscape as long as possible.</p> <p>There is some minor bark loss around the root crown on the Eastern side of the trunk. It should be monitored annually. If the bark loss continues to advance, then the tree may be suffering structural problems internally and may become a hazard. For now, the tree can be retained in the landscape.</p> <p>Maintenance: 20 min. Next Service: spring Priority: medium</p>

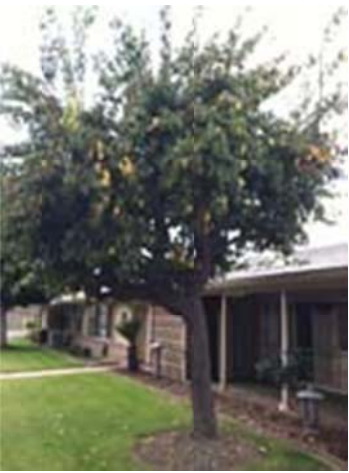
<p>Site 87 <i>Pyrus kawakamii</i> - Evergreen Pear</p> <p>This tree was tipped on all of its branches in the past, and it has since acquired the disease fire blight. The fire blight condition is systemic, and it will eventually cause the death of the tree. For now, the tree can be retained in the landscape, and the symptomatic tissue can be removed on an annual basis. Arborists who prune this tree should sterilize their tools in bleach to prevent the spread of the disease to other trees in the mutual. This tree should be pruned for roof and sidewalk clearance.</p> <p>Maintenance: 30 min. Next Service: spring Priority: medium</p>

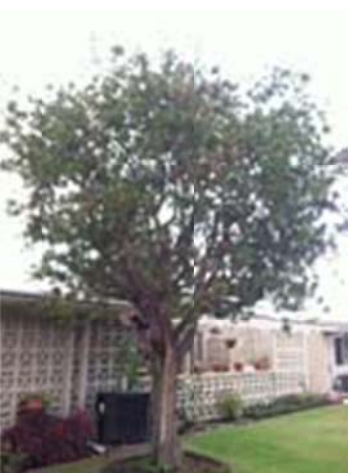
<p>Site 88 <i>Callistemon citrinus</i> - Lemon Bottlebrush</p> <p>This tree's canopy is looking a little sparse, and little foliage should be removed from it at this time. The tree only needs to be pruned for roof and sidewalk clearance.</p> <p>There are two staghorn ferns that are attached to the tree. They are hanging from screws that are driven into the trunks of the tree. Screws and nails should not be driven into the trunks of live trees because the wound creates an interface between the metal and the wood that harbors decay and disease. They should not be removed at this time because the act of removal will only damage the trunks further. The wound sites should be inspected annually for any advance of decay that could affect the structural stability of the trunks.</p> <p>There is an irrigation line that runs right through the center of the site, and there will eventually be conflict between the roots of this tree and irrigation line.</p> <p>Maintenance: 10 min. Next Service: spring Priority: medium</p>

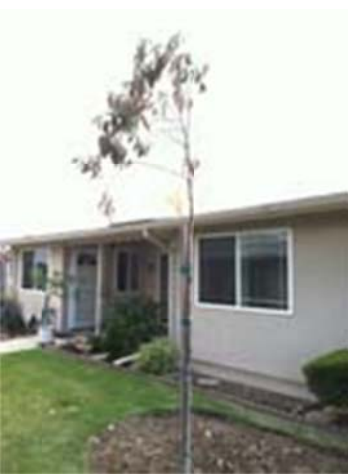
<p>Site 89 <i>Lophostemon confertus</i> - Brisbane Box</p> <p>This tree is extremely stressed. It is very tightly tied to its nursery stake, and the ties are cutting off circulation and damaging the bark. It was planted directly over an irrigation line and will likely have problems in the future if it pulls out of its decline. There are many dead branches, and the foliage is browning out from what appears to be a rust fungus. This tree will likely not live longer than two years and may need to be removed and replaced. The replacement tree should be planted closer to the sidewalk and further away from the irrigation line.</p> <p>The trunk of this tree is kinked in several places, indicating that it has been tied to other stakes earlier in its life before it was purchased from the nursery. If the tree is to be retained in the landscape, it should be re-staked properly with 2 stakes outside the root ball, allowing it to move freely in the wind and develop trunk taper.</p> <p>Maintenance: 20 min. Next Service: now Priority: high</p>

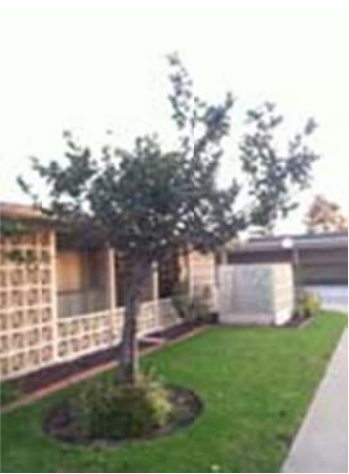
<p>Site 1 <i>Ilex spp.</i> - Holly Tree</p> <p>This tree has a severe wound in its trunk, and bark is actively retreating from it. There is significant decay that is running into the heartwood of the tree. It appears that the adventitious shoots at the base of this tree that grew in response to this wound have been periodically removed by the landscaping crew. This wound will ultimately cause the death of the tree, and the tree cannot be expected to be retained in this landscape for more than 5 to 10 years.</p> <p>The canopy is chaotic, and many of the shoots that form the canopy are a result of responses to poor pruning in the past. There is much deadwood that can be pruned out of the tree for aesthetic purposes. Previous pruning crews left stump cuts that are difficult for the tree to heal. The stumps should be recut back to the parent stem. There are some structural corrections to make in the tree, but because of the large wound on the trunk, the tree will not live long enough for these pruning cuts to matter. Rather, the tree should just be pruned for aesthetics as it begins its decline spiral.</p> <p>Maintenance: 10 min. Next Service: now Priority: medium</p>

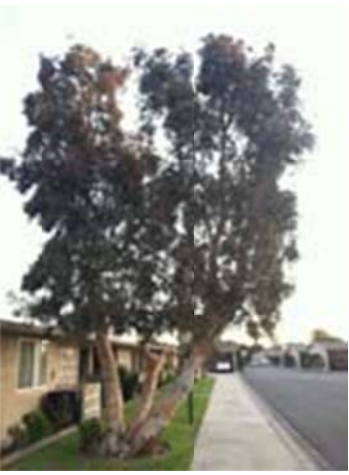
<p>Site 2 <i>Melaleuca quinquenervia</i> - Paperbark Tree</p> <p>This Melaleuca tree is well-chosen for the site because it has a controlled growth rate and roots that are less invasive than the other trees in the Eucalyptus family.</p> <p>In the past, one of the three major trunks was headed back. The tree has not yet begun to roll a cambium callous over the wound. This wound site should be monitored, and if decay begins to set in, then the entire trunk should be removed back to the root crown so that decay does not advance into the other two healthy trunks. Though attractive, this multi-trunk form will limit the tree's lifespan because all three trunks are in cantilever away from the root crown. It is likely that at some point in the next 20 years, the trunk to the South will fail into the street. It does not appear to be a concern at this time because there are no stress marks or signs of weakness in the trunk. The tree should be monitored annually for the possibility of failure, and it should be pruned for sidewalk clearance.</p> <p>Maintenance: 10 min. Next Service: now Priority: medium</p>

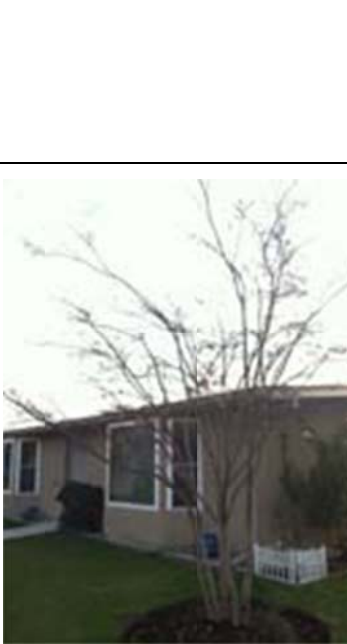
<p>Site 10 <i>Lagerstroemia indica</i> - Crape Myrtle</p> <p>This multi-trunk tree is a beautiful addition to the landscape. It should be pruned for roof and sidewalk clearance. There are only a few corrective cuts on this tree to remove rubbing and crossing structures. A few of the branches on the East side of the tree have a small fungus on the top side of the bark. This fungus is not serious at this time, but if it girdles the stem, then the afflicted branches will have to be cut back to their parent branches.</p> <p>Maintenance: 5 min. Next Service: now Priority: low</p>

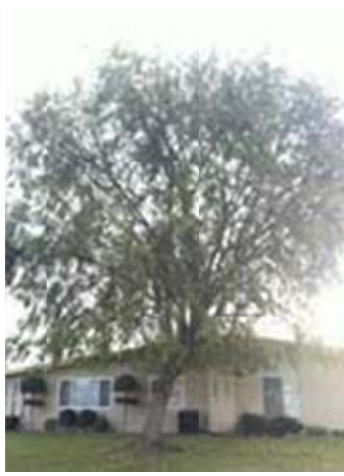
<p>Sites 21 <i>Salix babylonica</i> - Weeping Willow</p> <p>This species was not the best choice for this site. The weeping willow is known to have very aggressive roots, and this tree will likely cause damage to the foundation of the adjacent building. Already, there are some visible cracks and some displacement of hardscape. This tree is rapidly growing, as evidenced by the growth cracks up and down the main trunk. A decision should be made whether to retain the tree, or to remove and replace it before it does more damage to the infrastructure.</p> <p>There are some dead branches that are hanging in the canopy that should be removed immediately before they self-prune. Some of the heavier structures could be thinned to reduce the growth rate of tree temporarily. This tree will have a costly maintenance annually if it is retained in the landscape</p> <p>Maintenance: three hours with climber Next Service: now Priority: high</p>

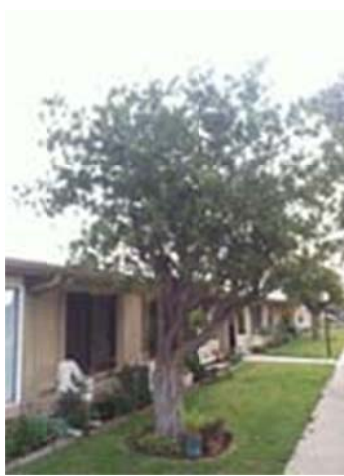
<p>Site 22 <i>Callistemon viminalis</i> - Bottlebrush</p> <p>This tree should be monitored for roof and sidewalk clearance. It was aggressively headed back in the past, and has since resprouted. The tree will recover, but some of the competing sprouts may need to be thinned over time. The biggest problem with this tree is its proximity to the building, but it can be maintained in its current form and location.</p> <p>Maintenance: 10 min. Next Service: now Priority: medium</p>

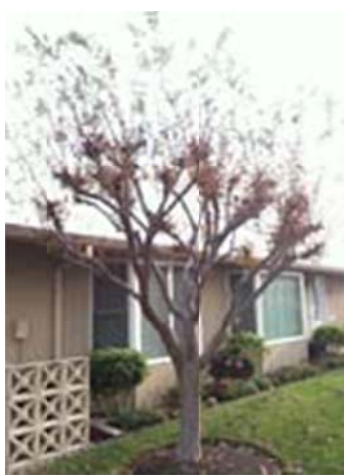
<p>Sites 32 <i>Lagerstroemia indica</i> - Crape Myrtle</p> <p>This tree was aggressively pollarded in the past, and each of these pollard points has re-sprouted chaotically. These small shoots should be thinned to train the tree into a good structural form. However, nothing should be done to this tree until after the spring growth flush. If the tree is not able to push out a new healthy canopy, then it may need to be removed and replaced.</p> <p>Maintenance: 20 min. Next Service: spring Priority: medium</p>

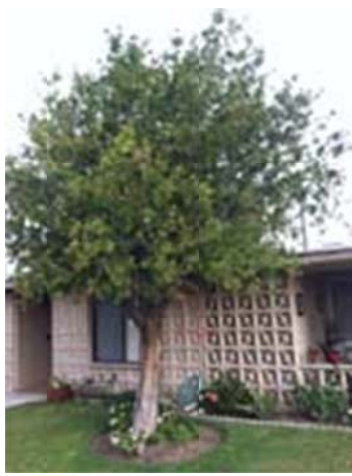
<p>Site 36 <i>Callistemon citrinus</i> – Lemon Bottlebrush</p> <p>This tree has been topped in the past, and the cuts have since re-sprouted into chaotic structures. These sprouts should be thinned to the strongest leaders to train the tree to a better structure. The tree should be maintained for roof and sidewalk clearance.</p> <p>Next Service: now Maintenance: 20 min. Priority: medium</p>

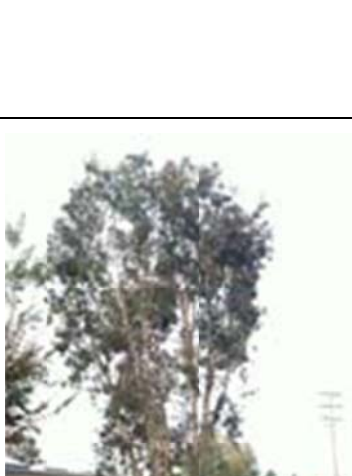
<p>Site 38 <i>Melaleuca quinquenervia</i> - Paperbark Tree</p> <p>This tree is a good choice of species, but it was planted a bit too close to the irrigation lines. There are two irrigation lines that run through this site that straddle the trunk of this tree. It is likely that the tree's roots will damage the irrigation line or maintenance crews for the irrigation line will have to cut roots of the tree.</p> <p>For now, this tree needs very little maintenance. There are only a few cuts to be made. There is one branch that is crossing a main trunk that should be pruned out.</p> <p>Maintenance: 10 min. Next Service: now Priority: medium</p>

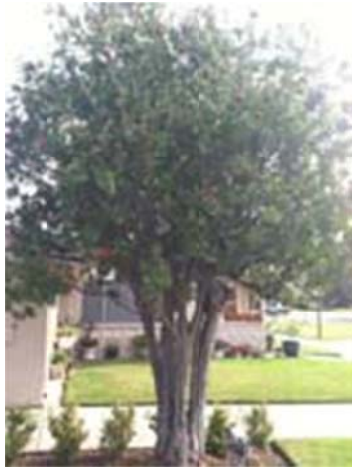
<p>Site 51 <i>Callistemon citrinus</i> - Lemon Bottlebrush</p> <p>This bottlebrush, like its neighbors, has been topped in the past, but it is recovering nicely. It should be maintained for sidewalk and roof clearance. It was planted a bit too close to the sidewalk, and the sidewalk may experience some damage from the root system.</p> <p>Maintenance: 10 min. Next Service: now Priority: medium</p>

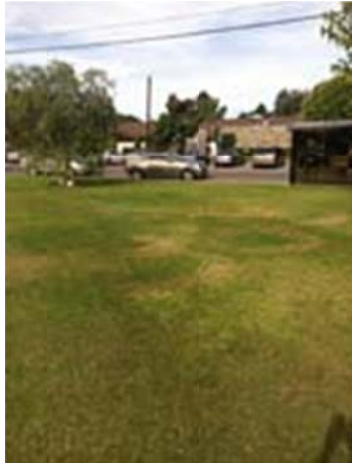
<p>Site 52 Vacant Planting Site</p> <p>This is a nice, large space for planting a shade tree. This tree has the potential to shade the bus station to the North of it. This site receives full southern exposure, and the tree should be heat and drought tolerant. Before planting in this site, the issues with drainage should be addressed.</p>

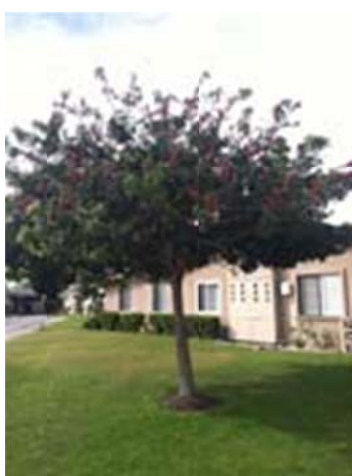
<p>Site 53 <i>Schinus terebinthifolius</i> - Brazilian Pepper</p> <p>This young tree has a healthy canopy, but the previous pruning has left some stumps that should be recut to their parent stems. There are some marks on the trunk where the tree was formerly tied to a stake. The bottom portion of the stake is impounded in the root system at the base of the trunk. It should not be removed because removing it would cause damage to the root system. Rather, it should be cut flush to the ground without damaging the bark so that is not a trip hazard. This species tends to grow rapidly and will need to be maintained every 6 to 12 months.</p> <p>Maintenance: 30 min. Next Service: now Priority: high</p>
