TREE INVENTORY

Prepared for
LEISURE WORLD MUTUAL 10
SEAL BEACH

Prepared by
JAMES KOMEN – CLASS ONE ARBORICULTURE
ISA CERTIFICATION #WE-9909A
(818)495-5344
CLASSONEARBORICULTURE@GMAIL.COM
DECEMBER 16, 2013

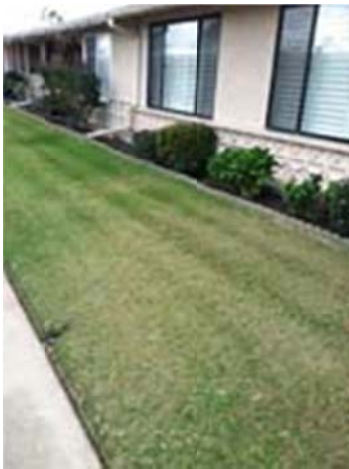
Sites 5, 6, and 8 Vacant Planting Site

These three sites would be good for a diminutive species that does not have aggressive roots. There is a limited planting space, but small trees could add to the aesthetic appeal of the landscape. Good suggestions would be purple leaf plum, Crape Myrtle, or a matching orchid tree.

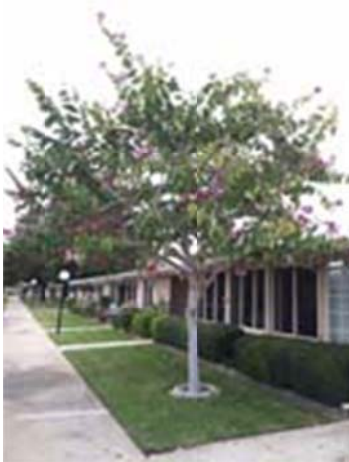
Site 7 *Bauhinia x blakeana* - Hong Kong Orchid

This orchid tree needs to be maintained for roof and sidewalk clearance. There is some minor deadwood that can be removed for aesthetic purposes.

Maintenance: 15 min.
Next Service: now
Priority: medium

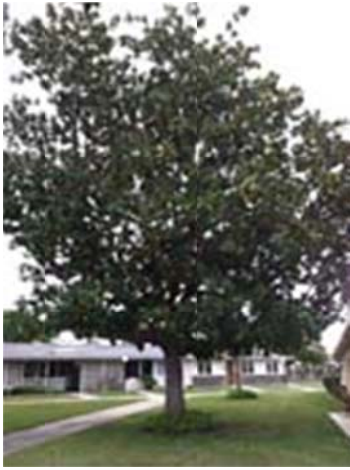
Site 9

Magnolia grandiflora - Southern Magnolia

Next Service: fall

Priority: medium

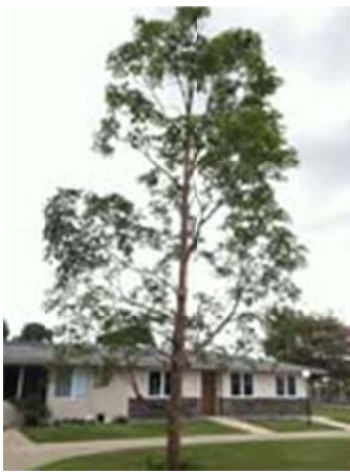
Site 10

Lophostemon confertus - Brisbane Box

Next Service: fall

Priority: low

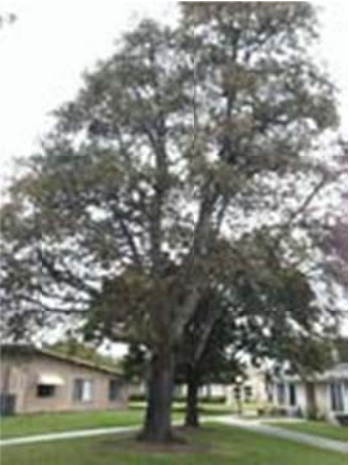
<p>Site 11 <i>Alnus rhombifolia</i> - White Alder</p> <p>This Alder tree has decent structural form and has plenty of room to grow. It is in competition with the neighboring Brazilian Pepper Tree to the East. Since the Brazilian Pepper Tree is less valuable, it should be pruned back to make way for the more valuable Alder tree. There is some minor deadwood in the Alder that can be removed for aesthetic purposes. There are several bird nests in the canopy, and care should be taken to not disturb them during the nesting season.</p> <p>One of the nests on the northern side of the canopy looks a little too large to be a bird nest. It could possibly be a rat nest. A pest expert should be asked to verify the identity of this nest and take any corrective action.</p> <p>There is some minor squirrel chew on some of the lateral branches, but this will not affect the long-term health of the tree. There are no signs of boring beetles in the trunk at this time, and the tree has many years of life left in the landscape. It should be maintained for sidewalk clearance.</p> <p>Maintenance: two hours with climber Next Service: fall Priority: low</p>

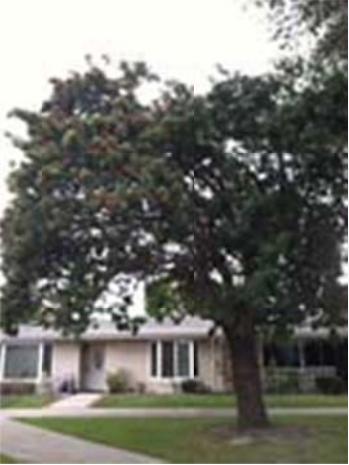
<p>Site 12 <i>Schinus terebinthifolius</i> - Brazilian Pepper</p> <p>This tree is a fast-growing species that will need to be maintained every 6 to 12 months. There is some deadwood in the canopy that can be removed for aesthetic purposes. This tree is in competition with the Alder tree to the West, and it should be pruned back to make way for the Alder.</p> <p>Maintenance: one hour Next Service: now Priority: medium</p>

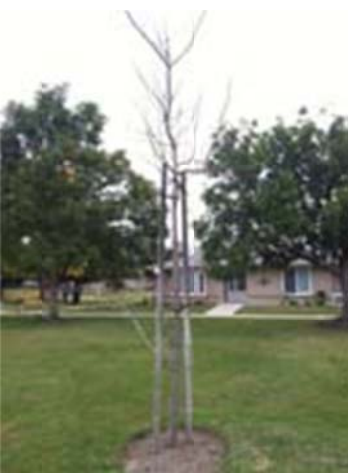
<p>Site 13 <i>Ginkgo biloba</i> - Maidenhair Tree</p> <p>This tree's stakes need to be removed immediately. The ties and stakes are causing abrasions on the trunk and branches of the tree. If the tree cannot stand on its own, it can be re-staked with two stakes placed outside the root zone of the tree. There is some evidence of squirrel chew on some of the lower branches, and these branches may need to be removed if they do not sprout in the spring.</p> <p>As of this report, the tree is still alive, but it is dormant. To verify whether the tree is alive or dead, lightly scratch the bark of a young twig with a fingernail. If it is green and moist underneath, then the tree is dormant. If it is dry and brittle, then it is dead.</p> <p>Maintenance: 10 min. Next Service: now Priority: high</p>

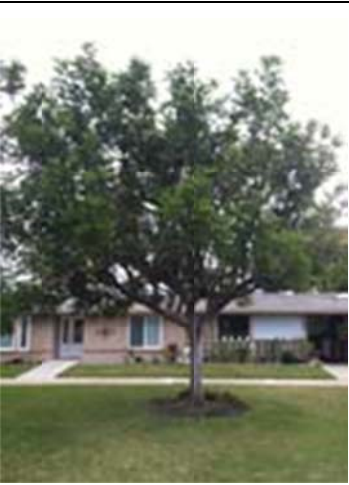
<p>Site 14 <i>Cupaniopsis anacardioides</i> - Carrotwood</p> <p>This Carrotwood tree has some minor bark fungus on some of its interior branches. At this time, no action needs to be taken, but if the branches die back they can be removed from the tree.</p> <p>In the past, this tree has been aggressively pruned and much of the foliage has been removed. There are some low hanging branches that should be removed for head height and sidewalk clearance. Once the tree is pruned for clearance, it should be allowed to grow and recover from its previous pruning.</p> <p>Maintenance: 15 min. Next Service: now Priority: medium</p>

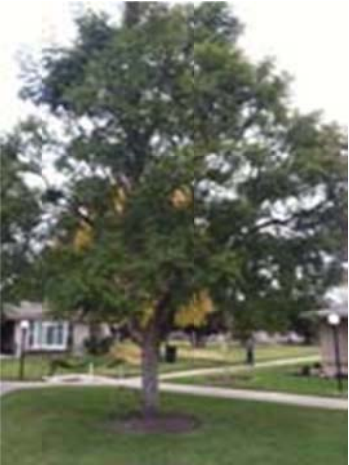
<p>Site 15 <i>Jacaranda mimosifolia</i> - Jacaranda</p> <p>This tree has a few structural corrections that should be made. There is a rubbing and crossing branch that is causing abrasion on one of the larger trunks. This tree should also be pruned for head height and sidewalk clearance.</p> <p>On the Eastern half of the trunk, there is a branch that divides into two co-dominant leads that are parallel with each other. As they grow, they will press up against each other and create a constriction in the vascular system. Also, the branch attach point will not increase in diameter as the branches increase in girth, which will make their union a weak point on the tree. The Eastern co-dominant stem could be removed, but it is not a high priority at this time.</p> <p>Maintenance: one hour Next Service: spring Priority: medium</p>

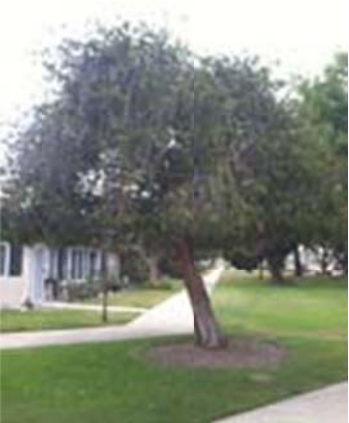
<p>Site 17 <i>Callistemon citrinus</i> - Lemon Bottlebrush</p> <p>This tree should be continued to be pruned for sidewalk clearance. It has been allowed to grow into a weeping umbrella form, which will have higher maintenance costs. To reduce the long-term cost of maintaining the tree, some of the lower down-pointing branches can be pruned back to their scaffold branches.</p> <p>Maintenance: 30 min. Next Service: spring Priority: high</p>

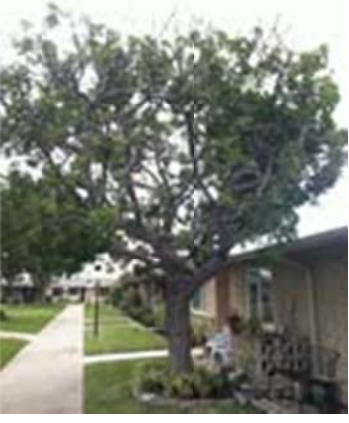
<p>Site 18 <i>Harpephyllum caffrum</i> - South African Wild Plum</p> <p>This tree is showing signs of tip dieback. The catalyst for this dieback could have been the aggressive pruning that the tree received in the past.</p> <p>The tree is also planted very close to the building and the irrigation line, and there may have been root damage causing the dieback on this tree. For now, it should be left alone to see if it can recover. It should be pruned for roof and sidewalk clearance only.</p> <p>Maintenance: 15 min. Next Service: spring Priority: medium</p>

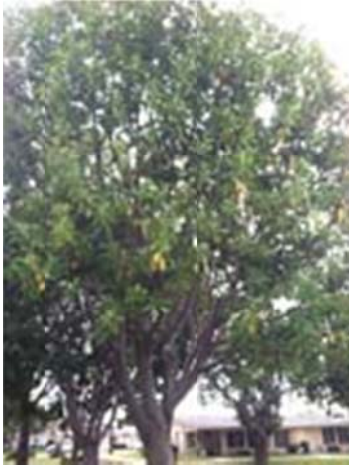
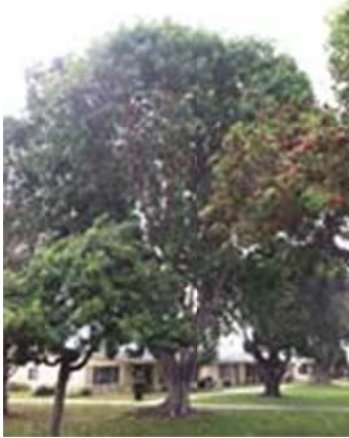
Sites 19 and 22
Ficus elastica - Rubber Tree

These two massive *Ficus* trees are dominant landscape assets. *Ficus* trees are naturally adapted to be the biggest, strongest, and fastest-growing trees in the forest. If they are not maintained properly, their imposing presence can turn into a landscape hazard.

Ficus trees are known to be root aggressive, and these trees have already caused damage to the adjacent sidewalk. To mitigate against the problem of root heaving, root barriers can be installed along the sidewalk next time it is serviced. A plastic root barrier should be installed to a depth of 12 to 16 inches to slow the growth of roots around and below it. It will not prevent the spread of roots, but it will slow them sufficiently that they will not cause much if any damage to the sidewalk. These trees can be thinned on their fringe every few years to reduce the likelihood of tearout. However, aggressive tipping will only create more of a hazard. If the height of these trees is not acceptable, then they should be considered for removal.

The tree at site 19 has a wound on the southern side of the trunk that is almost fully closed. However, behind the actively closing cambium is a cavity that is filled with water. There is nowhere for the water to drain, so decay organisms are able to thrive in this micro-ecosystem inside the trunk of the tree. Some arborists recommend drilling a drainage hole for the water, but I recommend against this because drilling a drainage hole would create a new wound site and actually speed up the decay process by exposing more surface area of heartwood to decay. Rather, this tree should be inspected annually. If it is determined that there is too much internal decay for the tree to be safe in the landscape, then it should be removed.

The tree at site 22 has two large wound sites at 4 feet up the trunk on the interior. It is actively rolling cambium over these wound sites, and it appears that they will close before decay advances into the main trunk. These wound sites should also be inspected annually to make sure that the decay is not advancing into the heartwood of the tree and creating a hazard.

Around the root crown of both trees, there are injuries to the buttress roots from lawnmowers. Buttress roots of these trees should be protected from lawnmower damage because the wound sites can become entry points for disease and decay. Landscapers should be reminded to be careful when mowing around buttress roots.

Both trees can be retained in the landscape for several years because they do not pose an imminent hazard, but they should be considered for long-term removal.

Maintenance: eight hours with climber
Next Service: spring
Priority: medium

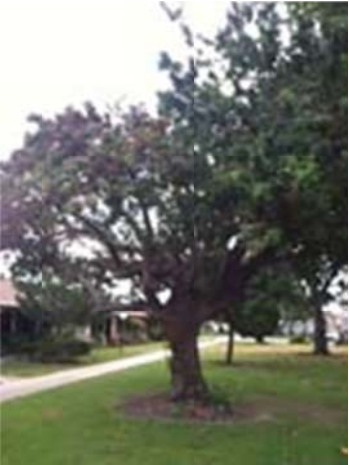
<p>Site 20 <i>Schinus terebinthifolius</i> - Brazilian Pepper</p> <p>This pepper tree is in competition with the rubber tree to the West, and some of its shoots should be pruned back to make way for the rubber tree's branches. There are some interior shoots on this tree that should be pruned back before they compete with the outer canopy. In the past, this tree was pruned back heavily, and it is still recovering from this pruning. After the interior shoots are removed, very little foliage needs to be removed from this tree.</p> <p>Maintenance: 30 min. Next Service: now Priority: medium</p>

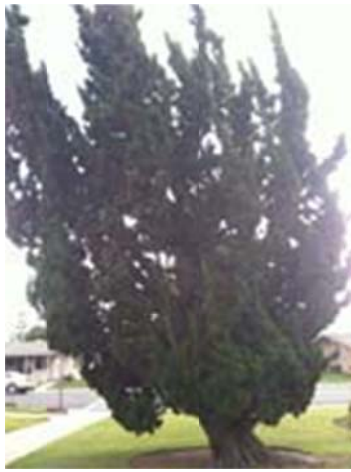
Site 25

Juniper chinensis - Hollywood Juniper

Next Service: now

Priority: low

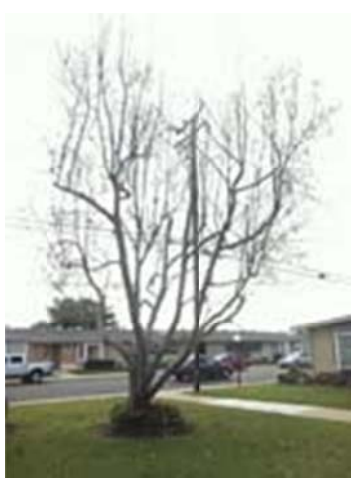
Sites 26

Liquidambar styraciflua - Sweet Gum

This tree has lost its main leading trunk, and this will ultimately be the wound site that limits the lifespan of the tree. It is currently being grown as a multi-trunk specimen. There are some abrasion wounds on the southern side of one of the low lateral branches. These wound sites may have been caused by impact with a passerby or landscape worker.

In the past, this tree was aggressively topped, and it is currently resprouting. For now, the tree can be retained the landscape because it is small enough that there is no likelihood of damage to structures nearby.

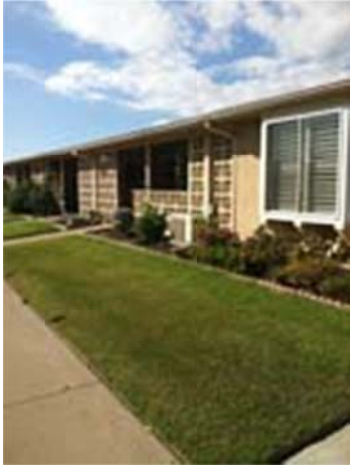
Site 31
Vacant Planting Site

This site should be utilized by a diminutive species. It receives full southern exposure, and the tree chosen should be tolerant of summer heat. A Crape Myrtle could do well on this site.

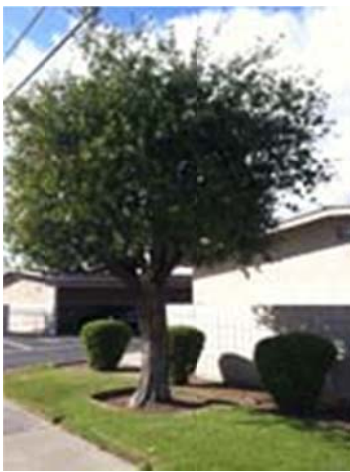
Sites 32 and 33
Callistemon citrinus - Lemon Bottlebrush

These two bottlebrush trees are attractive landscape features at the edge of these parking structures. There were planted directly below power lines and will need to be maintained annually for line clearance.

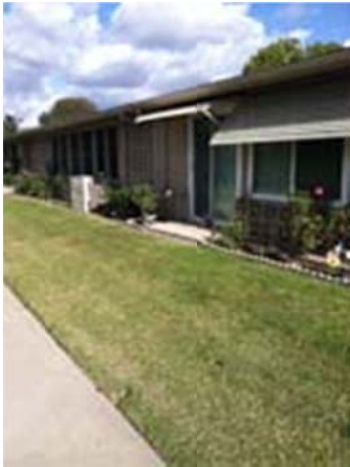
Site 40 through 43 Vacant Planting Site

These small planting sites could be utilized by a diminutive species with noninvasive roots. They all receive full Western exposure, and a tree that is planted on these sites should be tolerant of heat. Crape Myrtles could do well here.

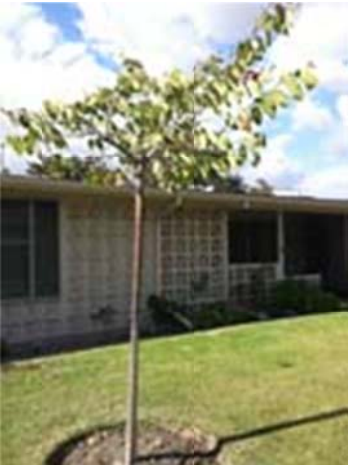
<p>Site 46 <i>Bauhinia x blakeana</i> - Hong Kong Orchid Tree</p> <p>This tree needs to be re-staked immediately. The ties are constricting the trunk of the tree, and the stake is pressed up against the trunk, creating abrasion marks. These wounds will be retained for the life of the tree and will eventually become weak points that could turn into failures. If the tree cannot stand on its own after the stake is removed, then it should be re-staked by driving two stakes into the ground outside the root ball and securing the tree with wire and hose tubing that allows it freedom to move in the wind. Without the freedom to move, the tree will never develop proper trunk taper that is necessary to stand on its own. There is some minor deadwood that can be cleared out of the tree and some minor structural corrections that will help the tree to develop a stable canopy.</p> <p>Maintenance: 20 min. Next Service: now Priority: high</p>

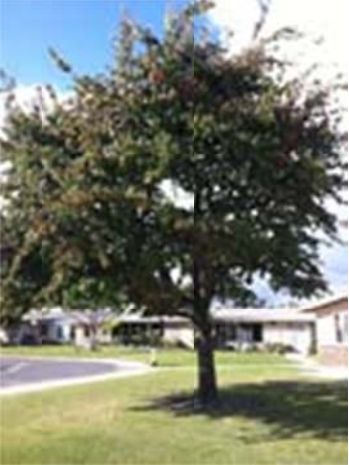
<p>Site 47 <i>Pyrus kawakamii</i> - Evergreen Pear</p> <p>This pear tree has severe symptoms of fire blight. It likely acquired the fire blight during a severe pruning in the past. Many of the branches have been tipped, and have since re-sprouted. There are symptoms on almost every leaf in the canopy of the tree. Eventually, the fire blight will kill the tree, but it can be retained in the landscape for several more years as it declines. If the tree is pruned, arborists should sterilize their pruning tools in bleach to prevent the spread of the disease to other trees in the mutual.</p> <p>Maintenance: 30 min. Next Service: fall Priority: low</p>

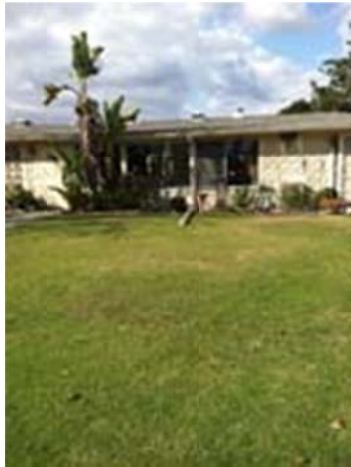
Site 48
Vacant Planting Site

This would be an excellent space for a shade tree. There is plenty of space for the roots to grow, and the building to the North would benefit from the shade.

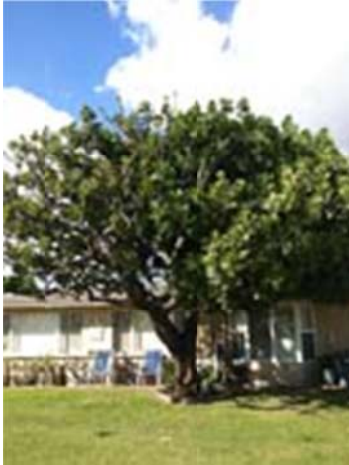
Site 50

Harpephyllum caffrum - South African Wild Plum

This tree has some severe stress cracks and is bleeding profusely from them. There are weeping sites up and down the main trunk and the secondary trunk to the Southwest. The weeping sites are wet, indicating that the tree is actively losing sap. There appears to be a darkening of the bark around these weeping sites, which indicates that there is a fungal infection present.

Within the stress cracks, there is decay present that has softened the heartwood of the tree, creating a structural problem. The tree does not pose an imminent hazard in the landscape yet, but it should be monitored annually. If decay advances too much and the structure of the tree is compromised, then the tree may need to be removed and replaced.

Next Service: spring

Priority: high

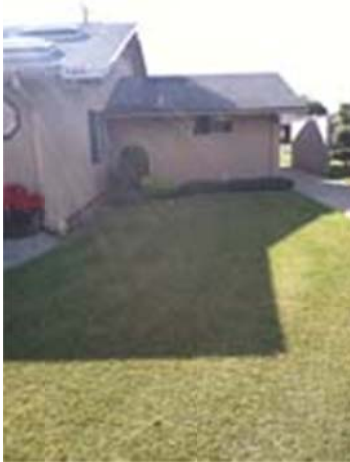
Site 51
Vacant Planting Site

This site receives protection from the Southwest by the adjacent building. This would be a good site for a diminutive species that would put an accent at the sidewalk intersection. This would be a good space for an Australian Willow.

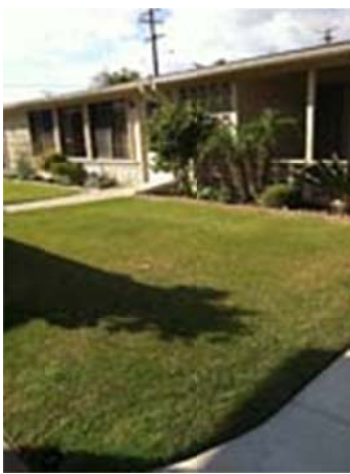
Site 52
Vacant Planting Site

This site receives full Western exposure. A tree that is planted here should be tolerant of summer heat.

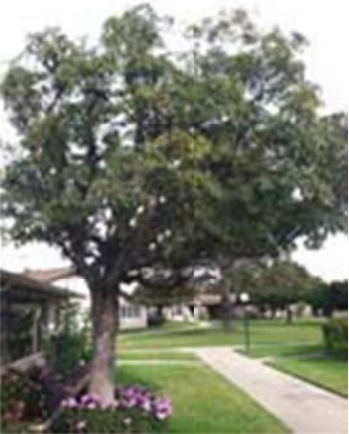
<p>Site 3 <i>Pittosporum undulatum</i> - Victorian box</p> <p>This tree has been aggressively pruned in the past, and is showing signs of stress. This tree should be allowed to recover for a growing season before structural correction pruning is done. There is some minor deadwood, but more may appear in one year's time, and the deadwood does not pose a hazard.</p> <p>This tree is planted in a small site that is limited by the building to the North and the irrigation line to the South. Because an irrigation line runs right through the center of this planting site, this tree has a limited space to grow. It will end up causing damage to the irrigation line, or its roots will be cut when the irrigation line is serviced.</p> <p>There is one small weeping site on the northern side of the trunk that should be monitored. If it turns into a more serious condition or if more weeping sites appear, then this tree may need to be treated for an infestation of boring insects.</p> <p>Maintenance: 20 min. Next Service: fall Priority: low</p>

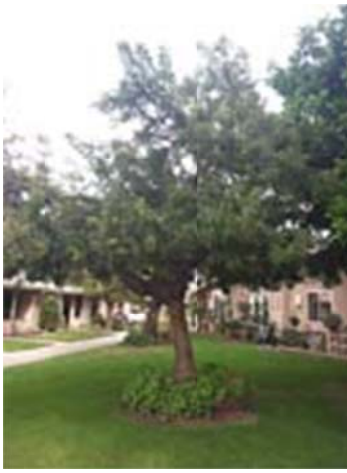
<p>Site 13 <i>Schinus terebinthifolius</i> - Brazilian Pepper</p> <p>This Brazilian Pepper was heavily pruned and is suffering. It was clipped at a height of 6 feet all the way around its fringe, and there are many stumps that need to be recut back to the parent stem. The upper canopy is showing signs of stress because of this pruning. If a few structural corrections are made, this tree can regain an attractive landscape form.</p> <p>Maintenance: one hour Next Service: now Priority: high</p>

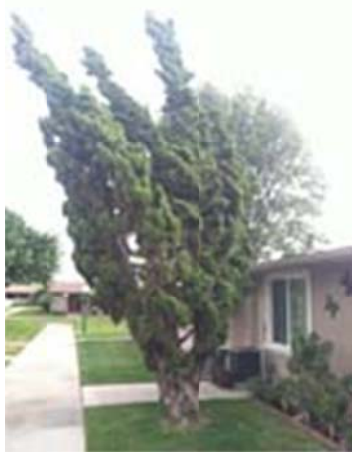
<p>Sites 20 <i>Juniperus chinensis</i> - Hollywood Juniper</p> <p>This is a low maintenance tree, but the homeowner has requested its replacement with a more attractive species. This tree is slated for removal and so it should not be pruned.</p>

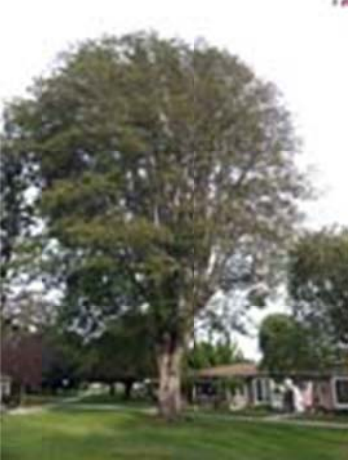
<p>Site 22 <i>Fraxinus uhdei</i> - Shamel Ash</p> <p>This ash tree has a significant load of deadwood that can be manicured out of it. The deadwood manicure will help the tree focus its energy on the growing tips, and also make the tree more aesthetic.</p> <p>In the past, this tree was topped at a height of around 20 feet, and has since resprouted from those topping cuts. The attach points of those sprouts are weak, and they are predisposed to failing in wind. The weakest branches should be pruned out before they fail. The tree should also be monitored for head height clearance.</p> <p>This tree is in heavy competition with the Silk Oak to the North at site 21. Some of its northern fringe should be pruned back to allow the Silk Oak space to grow. This ash tree will grow tall. If height is a concern, then it should be addressed gradually over a period of 2 to 3 years. The tallest leader should be cut back to subordinate branches that are capable of assuming apical dominance. The branches of an Ash tree should never be topped.</p> <p>Maintenance: five hours with climber Next Service: now Priority: medium</p>

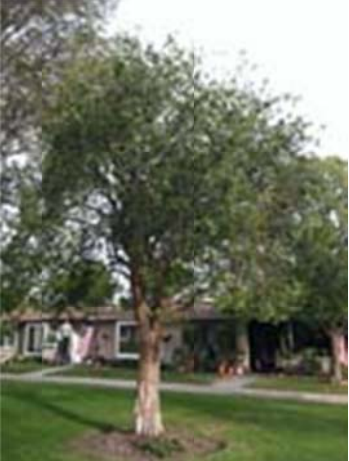
<p>Site 23 <i>Callistemon citrinus</i> - Lemon Bottlebrush</p> <p>This bottlebrush has foliage that appears very sparse. It should be allowed to grow for another season before pruning. If the tree is able to push out a fuller canopy, then the lowest hanging fringe can be pruned back. However, if the tree continues to decline, then it may need to be considered for removal and replacement.</p> <p>Maintenance: 10 min. Next Service: fall Priority: medium</p>

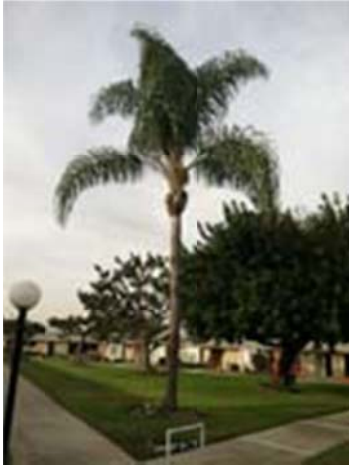
Site 29

This Palm has good form and will need to be maintained annually by removing the dead fronds and fruiting structures. This Palm has been climbed with spikes in the past, and the wounds from these climbing spikes remain. When palms are climbed with spikes, they retain these wounds for the rest of their lives. Live trees should never be climbed with spikes.

There appears to be a minor amount of fungus on the North side of the trunk. It is not serious at this time, but it should be monitored. If the fungus advances, then the structural integrity of the tree may be compromised.

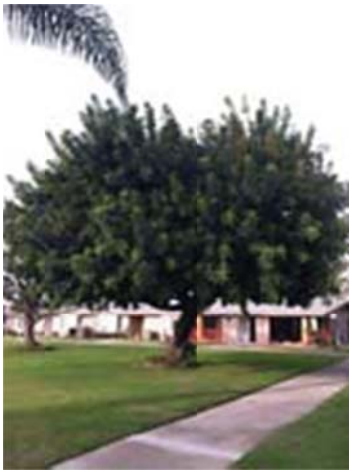
Site 30

This tree has several dead branches that should be removed before they self-prune. Many of the limbs have squirrel chew damage. These wounds should be monitored, because when they girdle the stems completely, the branches will die back to the main stem. The outer fringe is healthy, but the upper canopy is looking sparse because of the squirrel chew.

There are some surface roots that have been damaged by lawnmowers. Care should be taken when mowing around the base of this tree so that the roots are not injured.

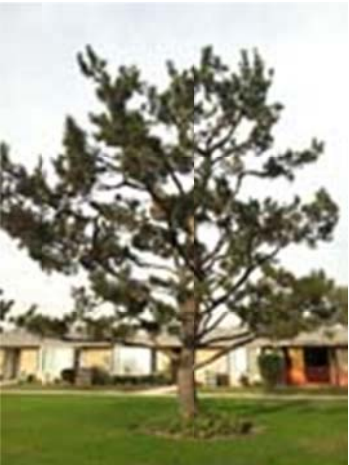
<p>Site 31 <i>Pinus radiata</i> - Monterey Pine</p> <p>This pine tree was severely pruned in the past, and too much live foliage was removed at once. It is currently in recovery mode, and no live foliage should be pruned off this tree for at least two years. There are a few dead branches that could be pruned out for aesthetic purposes. The tree should be sprayed with water to clear out the dead needles. This will improve light penetration and the photosynthetic potential of the tree.</p> <p>There appears to be some digging around the root crown of this tree. This practice should be stopped because digging usually involves cutting or damaging roots. If a tree acquires a major injury close to the root crown, then decay could enter and cause structural instability over the long term.</p> <p>Maintenance: 10 min. Next Service: now Priority: low</p>

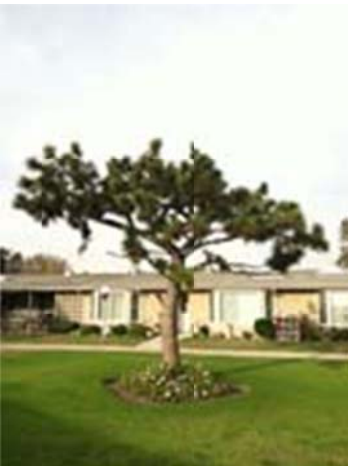
<p>Site 32 <i>Pinus radiata</i> - Monterey Pine</p> <p>Like its neighbor, this tree was over pruned in the past. It is currently in recovery mode. A bit of deadwood should be removed for aesthetic purposes, and the dead needles should be sprayed down with a hose.</p> <p>Maintenance: 10 min. Service: now Priority: low</p>

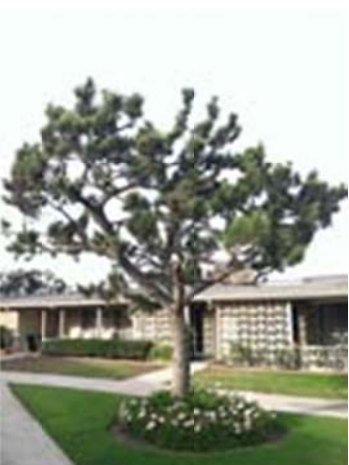
<p>Site 33 <i>Pinus radiata</i> - Monterey Pine</p> <p>Like its neighbors at sites 31 and 32, this tree was aggressively pruned in the past. It is in recovery mode, and no live foliage should be cut from it for at least two years. The dead needles should be knocked out of the canopy with a spray of water. There are a few stumps that should be recut back to the parent stems so the tree can begin to heal them.</p> <p>Maintenance: 10 min. Next Service: now Priority: low</p>

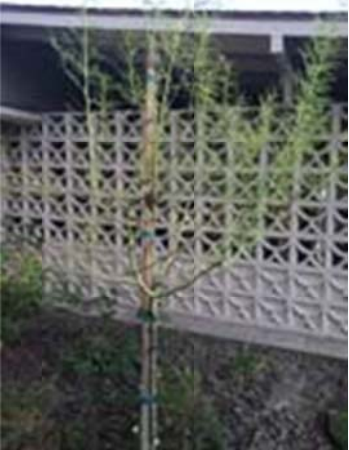
<p>Site 34 <i>Parkinsonia spp.</i> - Littleleaf Palo Verde</p> <p>This tree needs to be re-staked immediately. The ties are cutting off circulation and are leaving abrasion marks in the trunk. The stake that is pressed up against the trunk of the tree is creating stake dependency. The proper way to stake a tree is with 2 stakes, wire, and rubber tubing to support the tree but not put tension on the trunk. The tree will need to have some freedom to move in the wind so that it can develop trunk taper.</p> <p>There are a few correctional cuts that can be made on this tree that will improve its structure for the long-term</p> <p>Maintenance: 20 min. Next Service: now Priority: high</p>

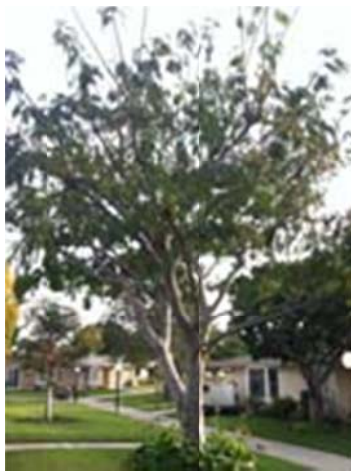
Site 39

This tree is relatively healthy, but there are new long branches that will need to be trimmed back for roof clearance. Previous pruning has caused new emerging sprouts to compete with each other for light. These sprouts are not strongly attached to the parent stem and should be trained to the strongest leaders. There are a few minor weeping sites on the tree that should be monitored annually. On the South Western side, there are two wounds that appear to be caused by torsional stress. This is possibly due to wind loads on the tree. If these wounds continue to weep, then there is a possibility that the large limbs may have to be removed before decay advances into the main trunk. For now, they should just be monitored.

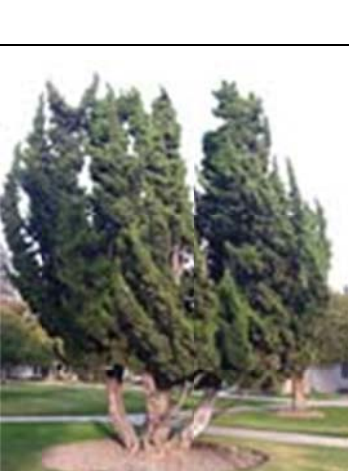
<p>Site 46 <i>Juniper chinensis</i> - Hollywood Juniper</p> <p>This is a low maintenance species that is attractive in the landscape. There are a few stump cuts that should be recut back to the parent stem. There is not much interior deadwood to be removed, but the tree should be cleaned for deadwood every 2 to 5 years. This is one of the lowest maintenance landscape trees.</p> <p>Maintenance: 20 min. Next Service: now Priority: low</p>

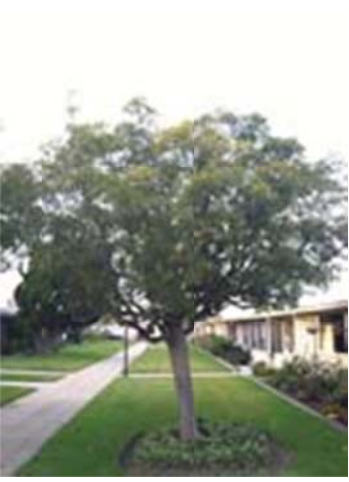
<p>Site 50 <i>Pittosporum undulatum</i> - Victorian Box</p> <p>This tree does not need any pruning at this time. It should be allowed to fight for space with its neighbor at site 51 because this will create a dense canopy cover over the sidewalk and will reduce the labor cost of maintaining the fringe.</p> <p>Maintenance: 10 min. Next Service: spring Priority: low</p>

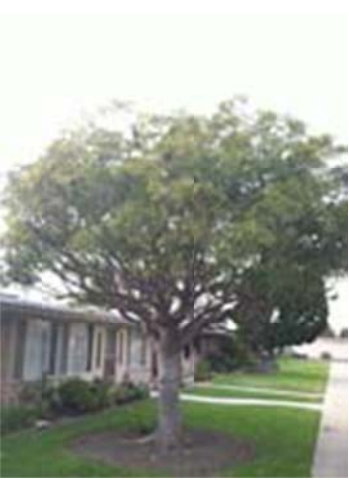
<p>Site 51 <i>Pittosporum undulatum</i> - Victorian Box</p> <p>This tree does not need any pruning at this time, but it should be monitored for sidewalk and roof clearance.</p> <p>Maintenance: 20 min. Next Service: spring Priority: low</p>

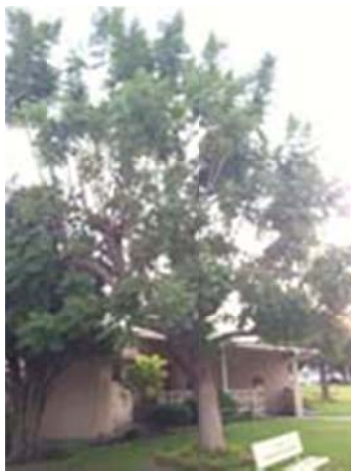
Site 56

This tree was very severely pruned in the recent past and has since re-sprouted. The new sprouts have grown chaotically and are competing with each other for light. This has created a canopy with very little lateral branching that is susceptible to wind throw and tearout. It is likely that these branches will begin to fail in the next major windstorm on this tree.

This species is fast-growing and has soft wood that can fail easily under stress. The previous pruning will likely be the determinant of its lifespan. This tree will have to be maintained often to keep it safe.

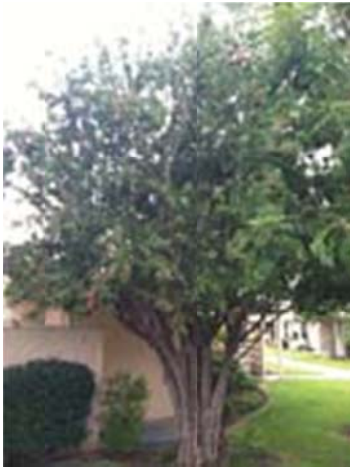
Sites 57 and 58
Callistemon citrinus - Lemon Bottlebrush

These bottlebrush trees were planted too close to the building and the electrical box. They will likely cause problems over time as they press against the foundation. There are already signs of the sidewalk cracking between the two trees. These trees will need to be maintained often for roof and building clearance. They should also be maintained for sidewalk clearance.

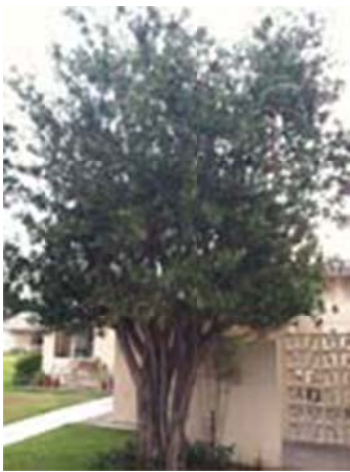
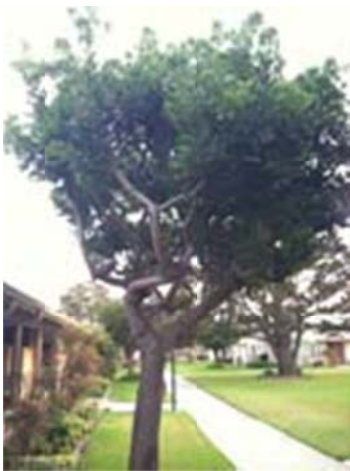
Site 59
Harpephyllum caffrum - South African Wild Plum

This tree was aggressively pruned in the past and is currently in recovery mode. It should not be pruned at this time, but after the spring growth flush, it should be assessed for structural corrections. It was planted too close to the building and the roots are already showing signs of lifting the infrastructure.

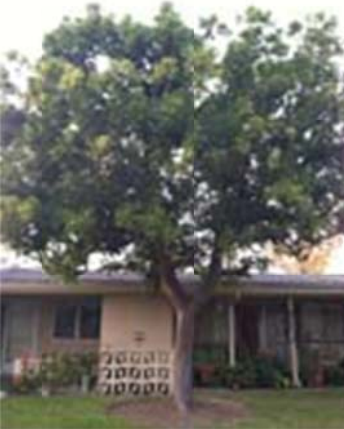
<p>Site 64 <i>Harpephyllum caffrum</i> - South African Wild Plum</p> <p>This tree has some tip die back that should be monitored. There is some deadwood in the canopy that can be removed for aesthetic purposes. It will need to be monitored for roof and sidewalk clearance.</p> <p>Maintenance: 15 min. Next Service: now Priority: medium</p>
 	<p>Site 65 <i>Lophostemon confertus</i> - Brisbane Box</p> <p>This tree's stakes need to be removed immediately. The ties are leaving abrasions on the trunk and are constricting the flow of water and nutrients to the canopy. This tree should be able to stand on its own. If it can't, then the stakes should be repositioned further apart, outside the root zone. Then the tree can be loosely tied with wire and rubber tubing that allows it the freedom to move in the wind.</p> <p>This was a good choice of nursery stock because there is branching nearly all the way to the ground. This will help the tree develop trunk taper and will create a strong structure in its future. The tree may end up causing problems to the sidewalks around it because it is a known root heaver. These problems won't likely appear for at least another 5 to 10 years.</p> <p>Maintenance: 20 minutes Next Service: now Priority: high</p>

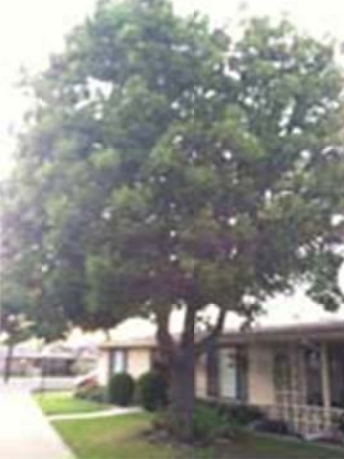
<p>Site 66 <i>Harpephyllum caffrum</i> - South African Wild Plum</p> <p>This tree needs to be maintained for roof and sidewalk clearance. There are some interior shoots that should be pruned out before they compete with the general canopy.</p> <p>Maintenance: 60 min. Next Service: spring Priority: medium</p>

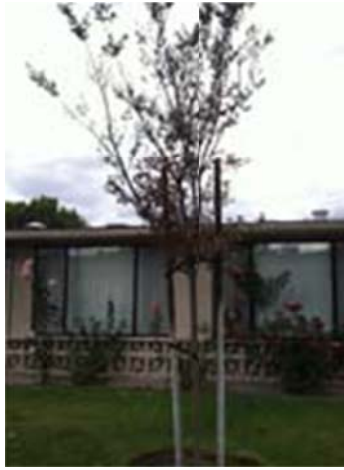
<p>Site 72 <i>Lagerstroemia indica</i> - Crape Myrtle</p> <p>This tree's stakes need to be removed immediately. They are creating abrasions on the trunk and constricting the flow of water and nutrients to the canopy. This tree has a very upright form, and lateral branching should be encouraged.</p> <p>Maintenance: 15 min. Next Service: now Priority: high</p>

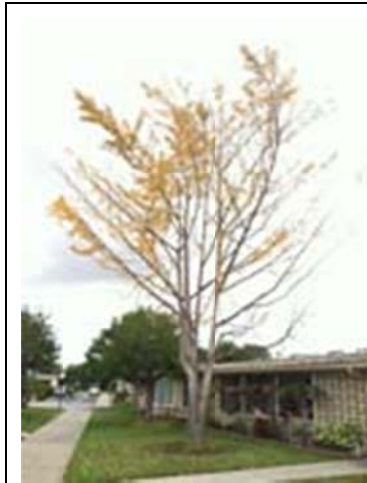
<p>Site 81 <i>Callistemon citrinus</i> - Lemon Bottlebrush</p> <p>This tree, like its neighbors, was pruned aggressively into a ball. It is currently in guarded condition, and not much live foliage should be removed at this time. Only a few cuts should be made for roof clearance. The leaves are beginning to yellow out, showing signs of stress. If the tree does not push out enough new foliage in the spring, then it may suffer decline in the summertime.</p> <p>There are several hanging planters in the tree that are hung from nails that are driven into the limbs. Driving nails into a tree limb creates a wound site that harbors decay and disease. Though this cannot be corrected at this time, it should be noted that nails should never be driven into live tree trunks or branches.</p> <p>Maintenance: 10 min. Next Service: spring Priority: medium</p>

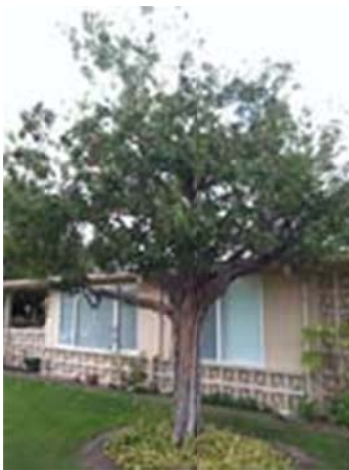
Site 82

Ginkgo biloba - Maidenhair Tree

There is a key structural defect in this tree at approximately 3 feet up the trunk. The tree has two co-dominant leaders with a narrow angle of attachment. The bark of each trunk is pressed together preventing the branch union from growing as they each increase in girth. This defect will eventually become a hazard for the adjacent building because the trunk to the South is most likely to fail. As the tree receives wind loads, the two co-dominant stems will oscillate much like a tuning fork. At the peak of the wave, all of the force of the wind is concentrated on the branch union of the co-dominant stems. A recommended mitigation for the co-dominant structure is to tie a safety line 2/3 of the way up into the tree. This will not prevent the tree from failing, but if it does fail, it will limit the damage to the building by holding the failed trunk of up against the remaining one.

There is some minor bark fungus affecting this tree, but it does not need to be mitigated at this time. If the afflicted branches die back, then they can be removed. There is some nursery stake plastic that is impounded in the bark of the northern trunk, and this remains from when the tree was younger and tied to its stake. This plastic should not be removed because its removal would create a larger wound site and do more harm than good. It should be cut flush to the trunk without damaging the bark.

Maintenance: one hour with climber
Next Service: now
Priority: medium

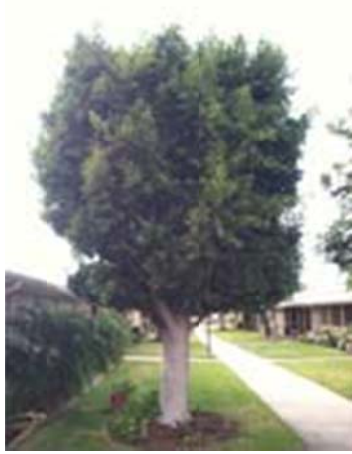
<p>Site 84 <i>Callistemon citrinus</i> - Lemon Bottlebrush</p> <p>This tree was aggressively pruned into a ball and is recovering. It will need to be pruned for roof and sidewalk clearance.</p> <p>Next Service: spring Maintenance: 10 min. Priority: medium</p>

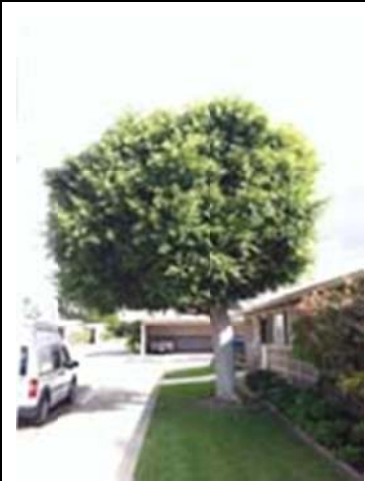
<p>Site 90 <i>Ficus microcarpa</i> - Indian Laurel Fig</p> <p>This tree was a poor choice of species for this location because it is an aggressive grower and has strong, aggressive roots. It will likely cause damage to the adjacent building's foundation and patio and the adjacent sidewalk and irrigation lines. If the tree is to be retained in the landscape, it will be costly for the landscape budget.</p> <p>Maintenance: two hours with climber Next Service: spring Priority: high</p> <p>Removal Recommended</p>
 	<p>Site 91 <i>Callistemon citrinus</i> - Lemon Bottlebrush</p> <p>This tree was planted a bit too close to the building and sidewalk, and there is a possibility that it will eventually cause damage to the infrastructure with its roots. The tree should be maintained annually for roof and sidewalk clearance.</p> <p>Maintenance: 10 min. Next Service: spring Priority: medium</p>
 	<p>Site 92 <i>Callistemon citrinus</i> – Lemon Bottlebrush</p> <p>Like its neighbor, this tree should be pruned for roof and sidewalk clearance.</p> <p>Maintenance: 10 min. Next Service: spring Priority: medium</p>

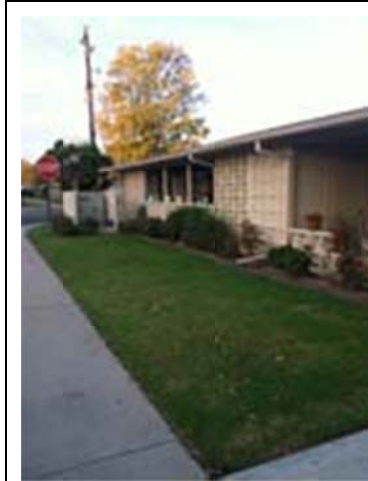
<p>Site 2 <i>Melaleuca quinquenervia</i> - Paperbark Tree</p> <p>This Melaleuca tree is well-chosen for the site because it has a controlled growth rate and roots that are less invasive than the other trees in the Eucalyptus family.</p> <p>In the past, one of the three major trunks was headed back. The tree has not yet begun to roll a cambium callous over the wound. This wound site should be monitored, and if decay begins to set in, then the entire trunk should be removed back to the root crown so that decay does not advance into the other two healthy trunks. Though attractive, this multi-trunk form will limit the tree's lifespan because all three trunks are in cantilever away from the root crown. It is likely that at some point in the next 20 years, the trunk to the South will fail into the street. It does not appear to be a concern at this time because there are no stress marks or signs of weakness in the trunk. The tree should be monitored annually for the possibility of failure, and it should be pruned for sidewalk clearance.</p> <p>Maintenance: 10 min. Next Service: now Priority: medium</p>

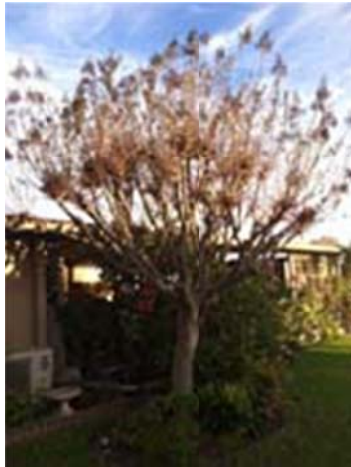
Site 4
Lagerstroemia indica - Crape Myrtle

This tree has been regularly topped, and its canopy has grown into a chaotic form. From each of the topping cuts, many shoots have re-sprouted in response. This is not an ideal form for the tree because the shoots compete with each other for light and tend to grow into long, spindly whips with little lateral branching. This can become a problem over 2 to 3 years because these whips will eventually grow to be large branches that are vulnerable to wind throw and tearout. To correct this problem early on, these shoots should be thinned to the strongest leaders. Any lateral branching should be retained.

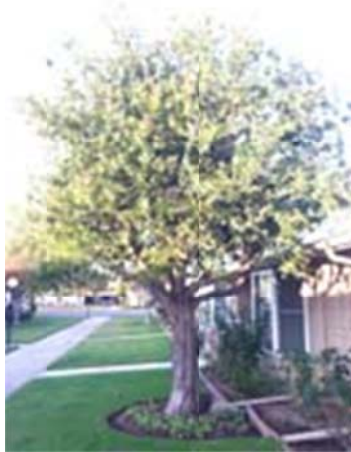
Site 7

Lagerstroemia indica - Crape Myrtle

This tree was headed back aggressively in the past. Following that pruning, the tree re-sprouted chaotically from each of the pollard points. There is not much live foliage on the tree at this time, and it should be monitored to see how much growth appears in the spring. If the tree shows signs of decline, then it may have to be removed and replaced.

Next Service: spring

Priority: low

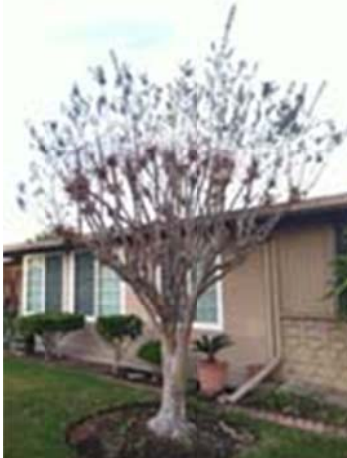
Site 8

Callistemon viminalis - Bottlebrush

This tree's planting site has an irrigation line that runs right through the center of it, and it is likely that either the roots of the tree will damage the irrigation line, or maintenance crews will damage the roots of the tree. As long as this tree is maintained for roof and sidewalk clearance, it can be retained until signs of root lifting appear.

Next Service: fall

Priority: low

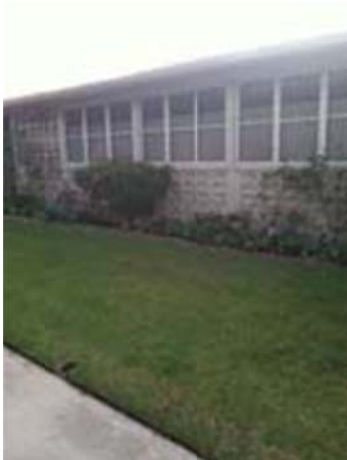
<p>Site 11 Vacant Planting Site</p> <p>This site receives shade from the South and would be ideal for a delicate, diminutive species. A tree should be chosen that does not have an aggressive root system.</p>

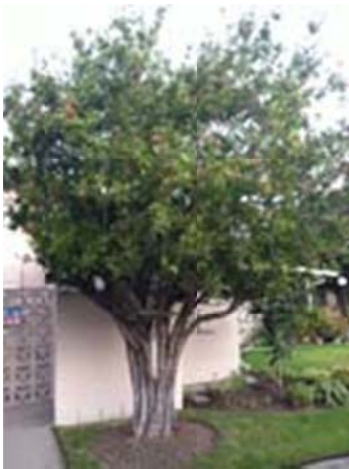
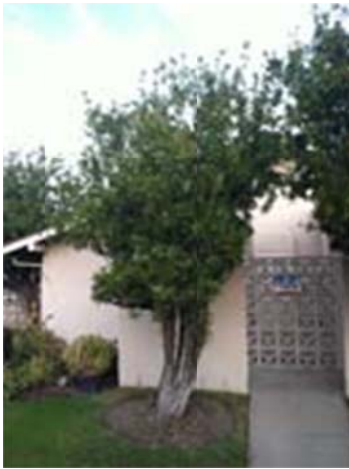
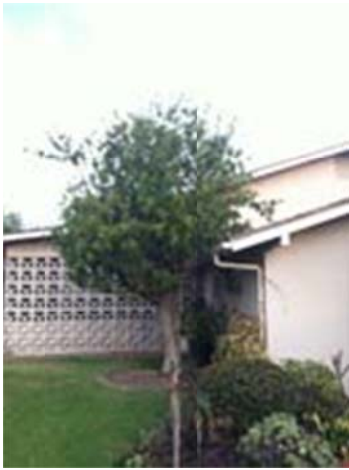
Sites 12, 13, and 14

Callistemon viminalis - Bottlebrush

The problem with these three trees began at planting. They were planted far too close to the building. When the trees grew larger, the maintenance crews aggressively topped all three of these trees. There will be a high cost of maintaining these trees because of their proximity to the building. To maintain roof clearance, branches will need to be pruned annually. Eventually, the roots of these trees may begin to cause damage to the surrounding hardscape because of their proximity to it. If this occurs, I recommend that no replacement tree be planted at sites 12 or 13. Rather, these sites are better suited to shrubs or bushes.

Next Service: now

Priority: high

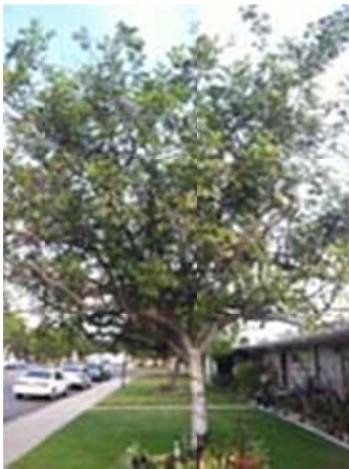
Site 15

Cupaniopsis anacardioides - Carrotwood

One of the big problems with this tree is its planting site. It is narrowly sandwiched between two irrigation lines that run right through the center of the planting site. Eventually, the roots of this tree will cause damage to the irrigation line, or maintenance to the irrigation line will cause damage to the tree roots.

Already, there are early signs of root damage on the trunk. There are some cracks that are turning into bark loss. Bark loss is often a telltale sign of root injury. The trunk of the tree is developing some fluting, which can indicate that there is an internal injury hidden in the trunk. This tree should be inspected annually, and if this bark loss continues, then the tree may have to be removed and replaced.

Next Service: now

Priority: medium

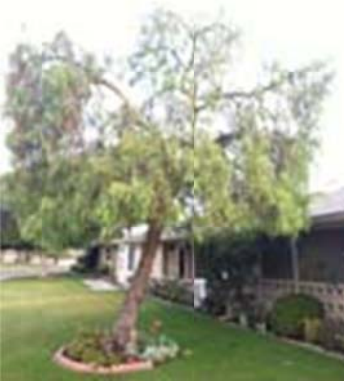
<p>Site 16 <i>Schinus molle</i> - California Pepper</p> <p>This is a good choice of tree for the climate, but a poor choice of tree for the site. It was planted between two narrowly spaced irrigation lines, despite its vigorous roots. It is likely that the roots of this tree will cause damage to the irrigation line over time.</p> <p>This tree has attractive weeping fringe that has been hedged in the past. Although this is not an Orthodox practice, it appears that the tree is beginning to adapt to its regular shearing, and it can be continued to maintain head height clearance only. This tree should be monitored for roof and sidewalk clearance.</p> <p>Maintenance: 20 min. Next Service: spring Priority: medium</p>

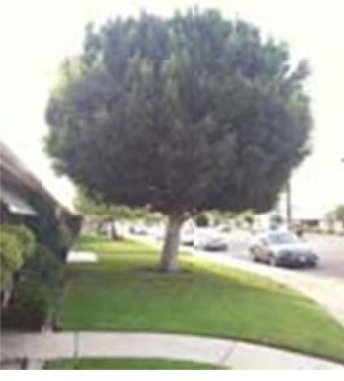
<p>Site 17 <i>Ficus microcarpa</i> - Indian Laurel Fig</p> <p>This was a poor choice of species for the location. <i>Ficus</i> trees are known to be very root aggressive, and this tree was planted very close to a building. Already, there are signs of roots that have lifted the walkway nearby and are beginning to cause damage to the foundation of the adjacent building. It is highly likely that this tree is also damaging the two irrigation lines that run immediately adjacent to the trunk on either side.</p> <p>The <i>Ficus</i> tree's natural adaption is to be the biggest, strongest, and fastest growing tree in the forest so that it can outcompete all of its neighbors. Therefore, this tree is very high maintenance because of its rapid growth rate. This tree will be expensive to maintain, and will likely cause costly damage to infrastructure. I recommend removing and replacing it before it causes any more damage. If there are not sufficient funds in the budget to remove and replace it at this time, then the tree should be monitored for sidewalk and roof clearance for the next year or two. If much more time passes, then the tree is likely to do some serious damage to the surrounding infrastructure.</p> <p>Removal recommended Priority: high</p>

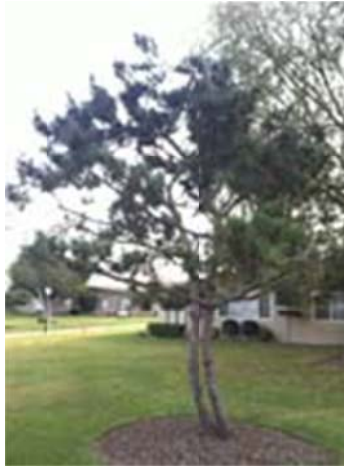
<p>Sites 20 <i>Pinus radiata</i> - Monterey pine</p> <p>This pine tree had the tips of most of its branches reduced. The pruning was a bit too aggressive, but it looks like the tree will recover. There are some dead needles in the canopy that can be sprayed down with water to improve the light penetration and the photosynthetic potential of the needles. No live wood should be taken from this canopy for at least two years.</p> <p>Maintenance: 10 min. Next Service: spring Priority: low</p>

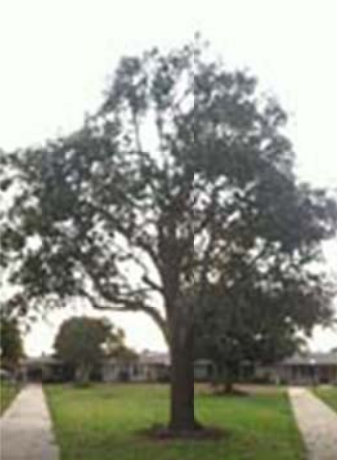
<p>Sites 23 <i>Alnus rhombifolia</i> - White Alder</p> <p>This Alder tree has been tipped many times in the past, and has since resprouted from these cuts. There is less foliage than would be ideal on this tree, and it should be allowed to recover. There are some wounds on the top side of the branches pointing to the North, and these wounds were likely caused by abrasion or squirrel chew. This tree should only be pruned lightly for sidewalk clearance at this time, but in coming years, it should be retrained to recover from the aggressive pruning in the past.</p> <p>Maintenance: 10 min. Next Service: now Priority: medium</p>

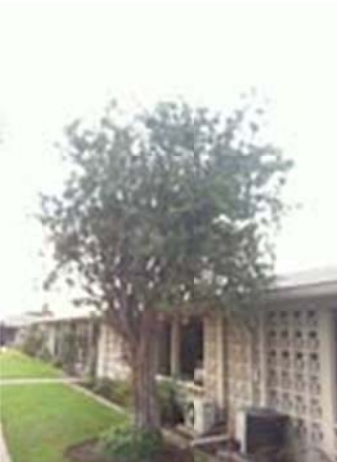
<p>Site 24 <i>Callistemon viminalis</i> - Bottlebrush</p> <p>Like its neighbor, this tree was aggressively headed back in the past. It has since resprouted, and it will recover from this pruning. However, it is planted a bit too close to the building and will likely cause damage to the infrastructure with its roots. For now, it can be retained by pruning for roof and sidewalk clearance.</p> <p>Maintenance: 20 min. Next Service: now Priority: high</p>

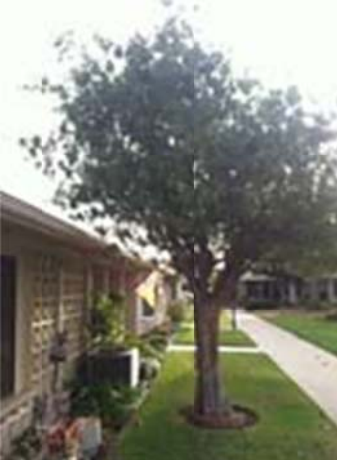
<p>Sites 25 <i>Callistemon viminalis</i> - Bottlebrush</p> <p>This bottlebrush tree, like its neighbor, was headed back aggressively in the past. It has since resprouted, and the shoots should be thinned to the strongest leaders. This tree should also be pruned for roof and sidewalk clearance. It may cause damage to the foundation of the adjacent building over time.</p> <p>Maintenance: 20 min. Next Service: now Priority: high</p>

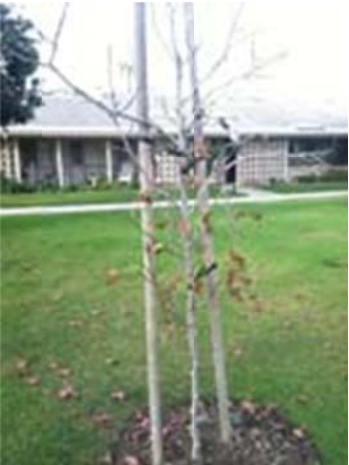
<p>Sites 26 <i>Acer spp.</i> - Maple</p> <p>This Maple tree was staked improperly, and the ties are doing damage to the trunk of the tree. The stakes need to be removed immediately. If the tree cannot stand on its own, then stakes should be installed further apart, outside the root zone. Ties should allow plenty of room for the tree to move in the wind. Ties should never put pressure on the trunk of the tree because they leave abrasion wounds that the tree will retain for the rest of its life. These ties are too tight, and they are cutting off the supply of water and nutrients to the top of the tree. The tree is already showing signs of drought stress on the leaves that are dying back from the tips. It should be monitored for next year's spring growth flush.</p> <p>Maintenance: 20 min. Next Service: now Priority: high</p>

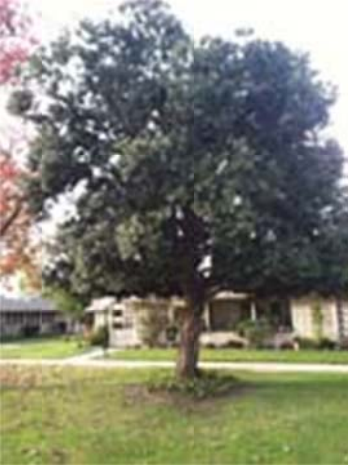
<p>Sites 27 <i>Metrosideros excelsus</i> - New Zealand Christmas Tree</p> <p>This tree is a good selection for the mutual because of its low maintenance. The fibrous structures that are dangling from the low branches are aerial roots that are growing towards the ground to supply the tree with more water and nutrients. The ones closest to the trunk can be allowed to grow, but the aerial roots that are further out should be pruned out of head height clearance because they will interfere with the general maintenance of the landscape. Though the water and nutrients supplied by these aerial roots are a benefit to the tree, they are not essential; these aerial roots can be pruned out if they become a nuisance. There are some minor tipping cuts on the sidewalk side of the tree that should be recut back to the parent stem.</p> <p>Maintenance: 10 min. Next Service: spring Priority: medium</p>
