TREE INVENTORY

Prepared for
LEISURE WORLD MUTUAL 10
SEAL BEACH

Prepared by
JAMES KOMEN – CLASS ONE ARBORICULTURE
ISA CERTIFICATION #WE-9909A
(818)495-5344
CLASSONEARBORICULTURE@GMAIL.COM
DECEMBER 16, 2013

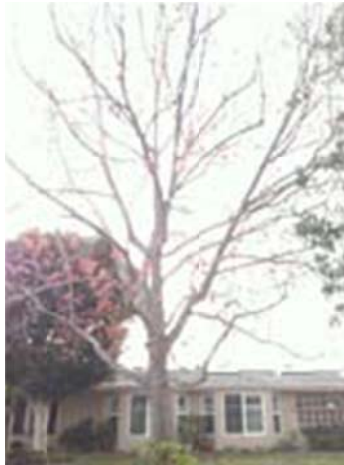
<p>Site 31 <i>Liquidambar styraciflua</i> – Sweet Gum</p> <p>This Sweet Gum tree is beginning to compete with the neighboring <i>Corymbia</i>. The Sweet Gum should be pruned back and yield to the more valuable flowering gum. It appears that it has been tipped in the past, and as a response, many of the branches have sprouted small shoots. These shoots can be retained at this time, but eventually, they should be trained to the strongest leaders to maintain a healthy, strong structure.</p> <p>Not much needs to be done to this tree at this time, but it should be monitored for sidewalk clearance.</p> <p>Maintenance: 10 min. Next Service: fall Priority: medium</p>

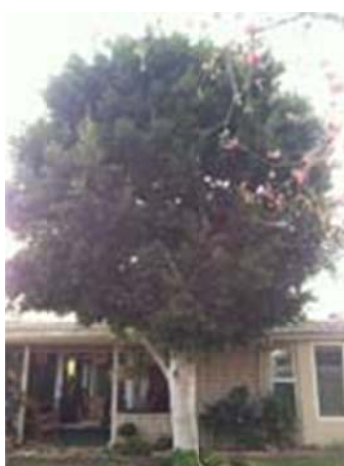
<p>Sites 33 <i>Ficus microcarpa</i> - Indian Laurel Fig</p> <p>This tree was a terrible choice for this site. It is in direct proximity to a walkway, to a building, and an irrigation line. Worse, it is situated directly over a sewer line. Ficus trees are known to have very aggressive roots, and the roots of this tree have probably found the sewer line and are actively damaging it. If nothing is done to this tree, it will continue to cause damage to the patio and the foundation of the adjacent building. Ficus trees grow very rapidly and are expensive to maintain annually. If this tree is to be retained, it should be pruned for roof clearance immediately.</p> <p>Priority: high</p> <p>Removal Recommended</p>

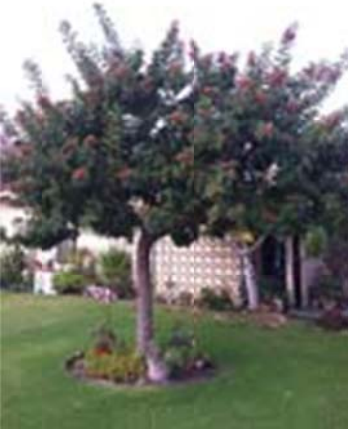
<p>Sites 34 <i>Schinus terebinthifolius</i> - Brazilian Pepper</p> <p>This young tree appears to be growing well. There is a dark streak around the trunk left by the tie that secured the tree to a stake when planted. The tie was left on for far too long and has left a permanent abrasion in the trunk of tree. The tree will retain this injury for the rest of its life, but it looks as though new cambium is being deposited, so it won't be a serious structural defect. There are some sprouts on the interior of the canopy that should be pruned out before they compete with the rest of the canopy. The tree should be pruned for head height clearance. The Brazilian Pepper is a high maintenance tree because it has a high growth rate. It may need to be pruned as often as every 6 to 12 months.</p> <p>Next Service: now Maintenance: 20 min. Priority: high</p>

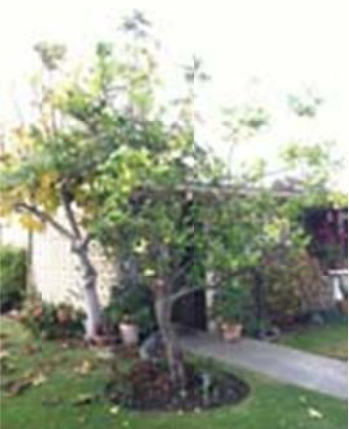
<p>Site 35 <i>Citrus x meyeri</i> - Lemon Tree</p> <p>This lemon tree has some severe structural problems. There is a large cavity at the root crown of the tree with active decay. On the North side of the trunk, there is an active weeping site. The tree has been aggressively pruned in the past, and it will retain these injuries for the rest of its life. There is substantial bark loss on many of the other branches, and a fungus is beginning to grow on them. On the top side of one of the southern branches, there is some evidence of squirrel chew.</p> <p>Citrus trees are usually not allowed in this mutual because of the rats they attract, and it is likely that this tree will need to be removed at some point in the future. If it is allowed to remain, then deadwood can be removed for aesthetic purposes. Not much needs to be pruned from the tree at this time.</p> <p>Maintenance: 15 min. Next Service: now Priority: low</p>

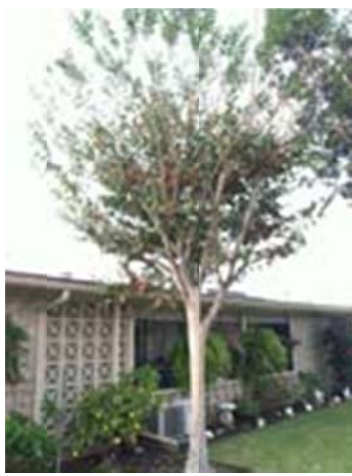
<p>Site 37 <i>Lagerstroemia indica</i> - Crape Myrtle</p> <p>This Crape Myrtle was aggressively topped and has re-sprouted from the topping cuts. There is sufficient live foliage on this tree to begin the re-scaffold restoration pruning. The weaker sprouts should be removed while retaining the strongest ones.</p> <p>Because of the pruning in the past, many of these shoots are competing with each other for light and growing into long, spindly structures with little lateral branching. Without lateral branching, these sprouts will not develop branch taper which is necessary to sustain wind loads as they grow.</p> <p>Maintenance: 30 min. Next Service: now Priority: medium</p>

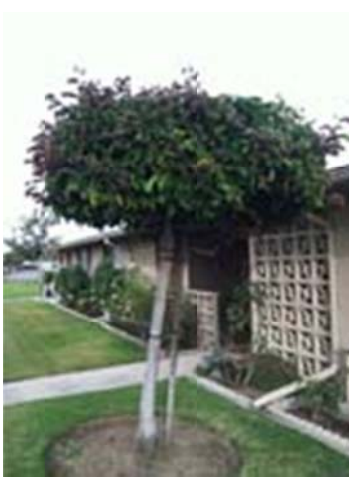
Sites 39

This tree needs to have its stakes removed immediately. The ties are creating constriction and are slowing the flow of nutrients and water to the canopy. One of the ties has already been cut, and it has left a dark abrasion mark on the trunk. It is likely that when the other two ties are removed, they will leave the same marks. It is possible that the stake has become impounded in the root system of the tree. If it is not possible to pull it out of the ground easily, then it should be cut flush to the ground without damaging the trunk. Attempting to break this stake could potentially cause damage to the root crown of this tree, defeating the purpose of removing it.

This tree appears to have a lean to the East and may not be able to stand on its own. The problem with this tree originated with the nursery stock selection because all of the foliage was concentrated at the very top of the tree. Since then, the management practice for caring for this tree was to hedge it into a ball. This has encouraged a chaotic internal branching structure, and there are many bark injuries from the previous hedging cuts. This tree will likely acquire decay through its wound sites, and it cannot be expected to have a long life in the landscape. Landscape crews can continue to maintain it in this same way until it dies because it would be an exercise in futility to try to restore this tree to its natural form. This tree will eventually have to be removed and replaced.

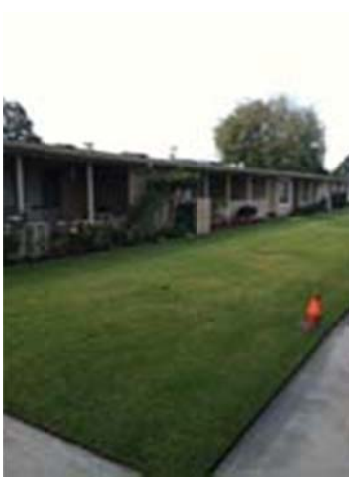
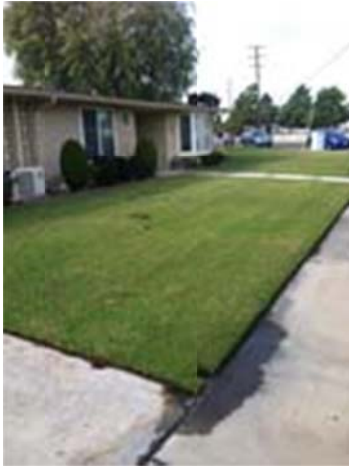
Sites 40 and 41 Vacant Planting Sites

These sites are smaller than they appear because they have two irrigation lines running right through the center of them. If a tree were to be planted here, it should be a diminutive species with noninvasive roots. The roots of almost any tree will eventually grow and cause damage to the irrigation lines, or maintenance of the irrigation lines will necessitate damage to the root system.

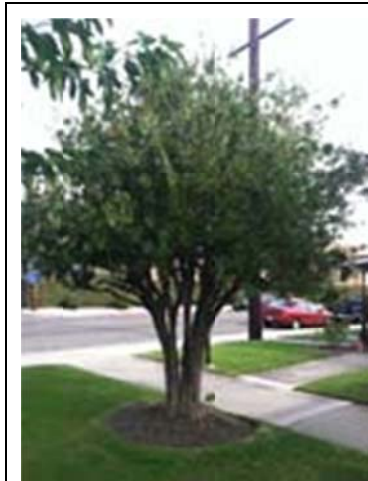
Site 48
Callistemon citrinus – Lemon Bottlebrush

This bottlebrush is growing well, but it will need to be maintained for sidewalk clearance. Its branches were tipped in the past, but they appear to be recovering. Its canopy can be allowed to compete with its neighboring bottlebrush because they are evenly matched. This will reduce the amount of necessary maintenance on the interface between these two trees.

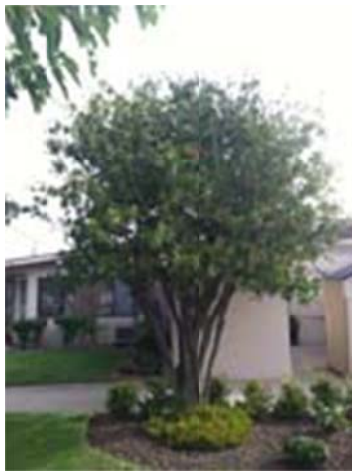
Site 49
Callistemon citrinus – Lemon Bottlebrush

This tree needs to be trimmed for roof clearance and sidewalk clearance. It has acceptable ground cover around its base that is protecting the trunk from passersby and landscape workers. As long as this tree is maintained for roof and sidewalk clearance, it can be retained in the landscape. Long-term, it may cause some damage to the sidewalk because it was planted so close to it.

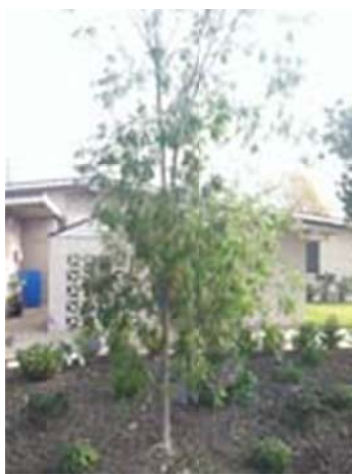
Site 50
Callistemon viminalis - Lemon Bottlebrush

This young bottlebrush has excellent form. There is a co-dominant leader about 6 feet up the trunk, but the angle of attachment is large enough that it does not pose a tearout hazard at this time. The foliage on this tree should be allowed to grow to the ground because this is the natural form of the tree. There is no need to raise the crown of this tree for several years.

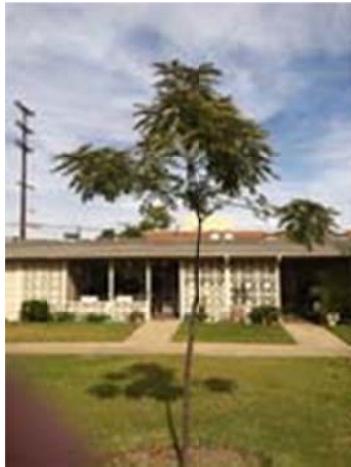
Site 54

This tree is not looking good. There are major abrasions on the South side of the trunk about 4 feet up. These abrasions are causing bark loss, and these wounds will remain with the tree for the rest of its life, potentially creating weak points for failure. There are abrasion marks from the ties that were holding the tree to the stake. These marks will also be retained for the rest of the tree's life. The foliage is looking sparse, and the leaf margins are showing signs of scorch. This is an indicator that the tree is getting cooked by the heat of the summer. This tree should be monitored for signs of further decline. There is a possibility that the tree will die and need to be replaced. In the short term, the tree can be pruned for aesthetics by removing the dead tissue.

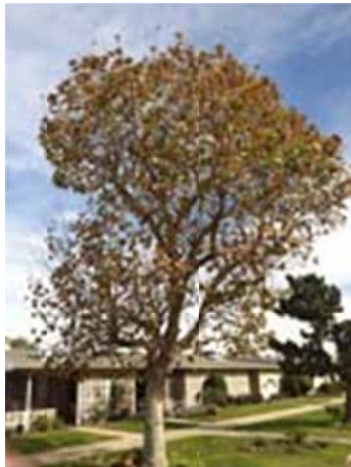
Site 55

This tree has good structure. There is a minor tearout wound on the Eastern side about 8 feet up one of the branches. This wound should be monitored, and if the cambium is not able to roll over and close the wound, then this branch may need to be removed to prevent the spread of decay to the main trunk.

The leaves have anthracnose which is a common condition for the *Platanus* genus. It is a foliar fungus that spreads by splashing water, and it thrives in cool, wet conditions. The condition is not a major concern for the long term health of the tree. The brown leaves are aesthetically unattractive, but eventually the tree will drop them and grow new, fresh leaves. Anthracnose only becomes a problem if it browns so many of the leaves that it severely limits the ability for the tree to photosynthesize. This does not appear to be the case on this tree, and no action needs to be taken at this time. The tree should be inspected next year.

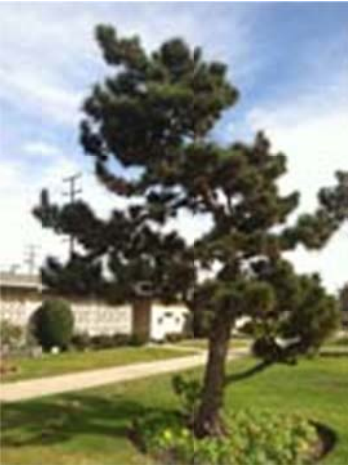
<p>Site 56 <i>Pinus radiata</i> - Monterey pine</p> <p>This pine tree has good form. The dead needles can be cleaned out of the canopy by spraying the tree with water. A simple crown cleaning will improve light penetration to the live needles and increase the tree's photosynthetic potential.</p> <p>Maintenance: 10 min. Next Service: spring Priority: low</p>

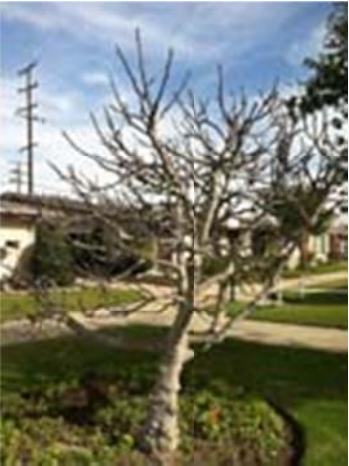
<p>Site 57 <i>Ficus carica</i> - Edible Fig</p> <p>This fig tree is currently dormant, but the structure is acceptable. There are some stump cuts that should be returned back to the parent stem. The species tends to not grow very large, so it is not problem tree like its cousins <i>Ficus microcarpa</i> and <i>Ficus benjamina</i>. Rodents tend to like to eat the fruit of this tree. If the rodents become a nuisance, then the tree may need to be removed. However, it can be retained with relatively low pruning maintenance.</p> <p>Maintenance: 10 min. Next Service: spring Priority: low</p>

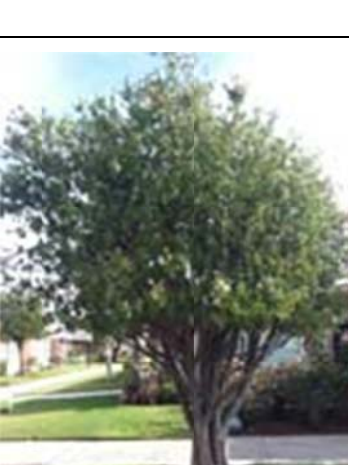
<p>Site 58 <i>Callistemon citrinus</i> – Lemon Bottlebrush</p> <p>This bottlebrush is recovering from its topping some years back. Some of the new sprouts should be trained to the stronger ones. This tree should be monitored for sidewalk clearance.</p> <p>Maintenance: 10 min. Next Service: now Priority: high</p>

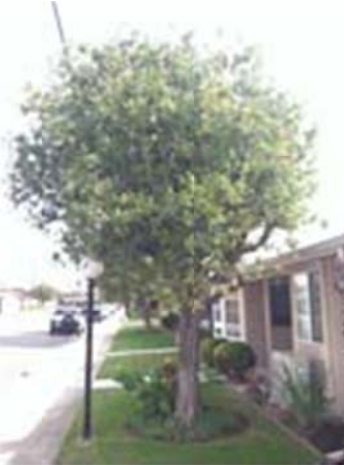
<p>Site 62 <i>Callistemon citrinus</i> - Lemon Bottlebrush</p> <p>This tree is recovering from its pruning several years ago, and the sprouts that it has grown in response should be thinned to the strongest leaders. This tree should also be pruned for roof and sidewalk clearance. There is little bit of deadwood in the canopy that can be removed as well.</p> <p>Maintenance: 20 min. Next Service: now Priority: medium</p>

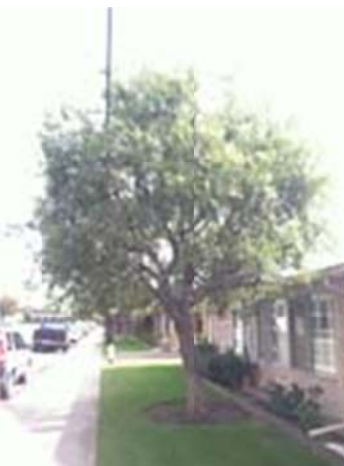
<p>Site 63 <i>Callistemon viminalis</i> - Bottlebrush</p> <p>This bottlebrush is recovering from its topping wounds from the past. It has a bit of a problem because it is growing below the power lines. Many of its branches are already in contact with the lowest of the electrical lines. This tree should be pruned for line clearance as well as roof and sidewalk clearance. It will be costly to maintain this tree in the long run because the site space is limited. To save on maintenance, this tree can be replaced with a smaller species that will crown out below the height of the power lines.</p> <p>Maintenance: 40 min. Next Service: now Priority: high</p>

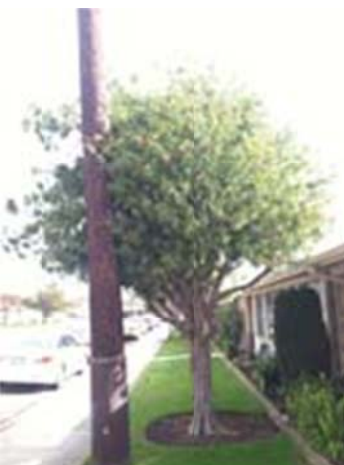
<p>Site 64 <i>Callistemon citrinus</i> - Lemon Bottlebrush</p> <p>This tree was heavily pruned in the past, and it is recovering from that pruning episode. There is some deadwood in the canopy that should be removed, and the tree should be pruned for roof, sidewalk, and line clearance. Unfortunately, this tree will be relatively high maintenance because of all of the points of clearance that are required.</p> <p>Maintenance: 30 min. Next Service: now Priority: high</p>

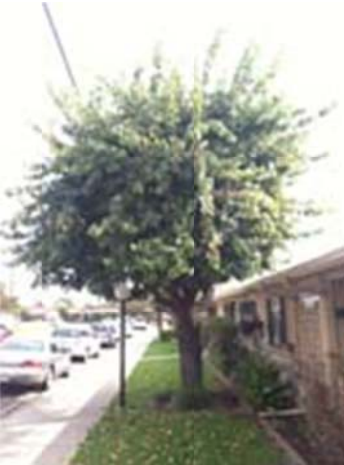
<p>Site 65 <i>Pyrus kawakamii</i> - Evergreen Pear</p> <p>This tree was topped heavily in the past, and it now has fire blight. The pruning wounds were likely the entry point for the infection. Fire blight is systemic, so it has already spread throughout the entire tree. The fire blight will eventually be the cause of death for the tree in the long run. The tree can be retained in the short run by removing the symptomatic tissue periodically. Arborists who prune this tree should sterilize their tools between cuts to prevent the spread of the disease to other trees in the mutual. This tree should also be pruned for line, roof, and sidewalk clearance.</p> <p>Maintenance: 40 min. Next Service: now Priority: high</p>

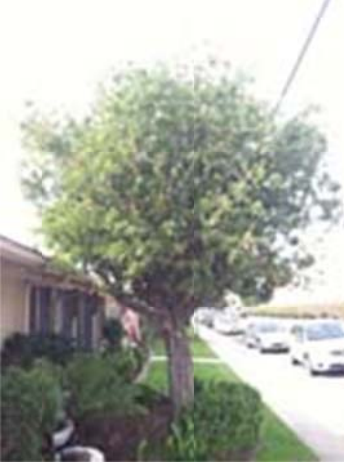
<p>Site 66 <i>Callistemon citrinus</i> - Lemon Bottlebrush</p> <p>This bottlebrush tree will need to be pruned for roof, sidewalk, and line clearance. The understory ferns around the base of the tree provide good protection for the tree by discouraging passersby and maintenance workers from directly contacting the trunk of tree.</p> <p>There is some minor deadwood in the canopy that could be removed, and some of the shoots that are growing in response to its past pruning should be thinned to help re-culture a strong canopy structure.</p> <p>Maintenance: 20 min. Next Service: now Priority: medium</p>

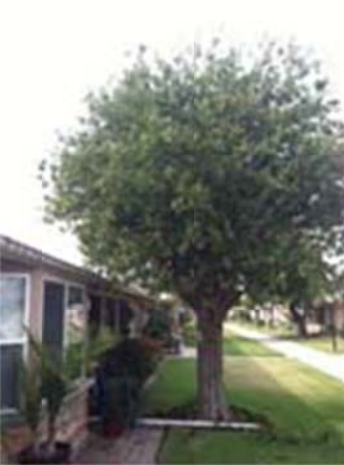
<p>Site 67 <i>Callistemon citrinus</i> - Lemon Bottlebrush</p> <p>This bottlebrush will need to be monitored for roof and head height clearance. There are some minor structural corrections that could be made on the interior of the canopy. Unfortunately, this tree was planted a bit too close to the building, and it is likely that the roots will cause damage to the patio and possibly the foundation of the adjacent building.</p> <p>Maintenance: 20 min. Next Service: now Priority: medium</p>

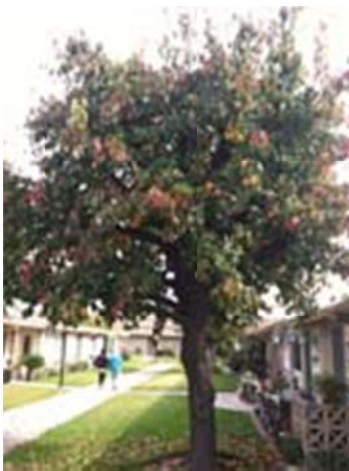
Sites 68 and 69
Pyrus kawakamii - Evergreen Pear

These two pear trees have fire blight. This was likely acquired in the aggressive pruning that was done in the past. Fire blight is a systemic condition and has already translocated throughout the entire tree. Although the fire blight will eventually cause the death of the tree, the trees can be retained for several more years. Arborists can annually prune out the symptomatic tissue for aesthetic purposes. Pruning tools should be sterilized in bleach to prevent the spread of the disease to other trees in the mutual. These trees should be pruned for roof clearance.

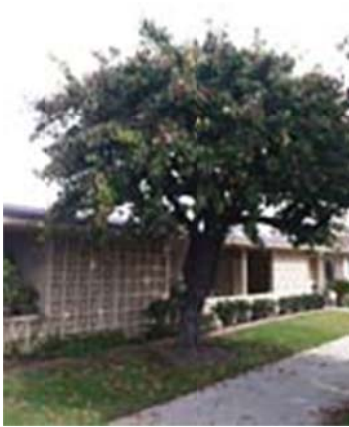
<p>Site 70 <i>Bauhinia x blakeana</i> - Hong Kong Orchid</p> <p>This tree was poorly installed. The ties are too tight around the trunk of tree and are leaving abrasion marks. The trunk is pressed up against a stake that is causing the tree to become stake dependent; this stake should have been removed at planting. If the tree cannot stand on its own now, then it should be re-staked properly with wires and rubber tubing that allow the tree room to move and develop trunk taper.</p> <p>There is deadwood in the canopy that should be removed for aesthetics. There is also a bark fungus that is on this tree. If the fungus girdles the trunk, then it will cut off the water and nutrients to the rest of the canopy and kill the tree.</p> <p>The tree was planted almost immediately over a in the irrigation line. Inevitably, there will be problems with either the irrigation line being damaged by the roots, or the roots being damaged by irrigation maintenance crews. I spoke with the homeowner, and she is interested in replacing this tree with correct planting practices.</p> <p>Maintenance: 25 min. Next Service: now Priority: high</p>

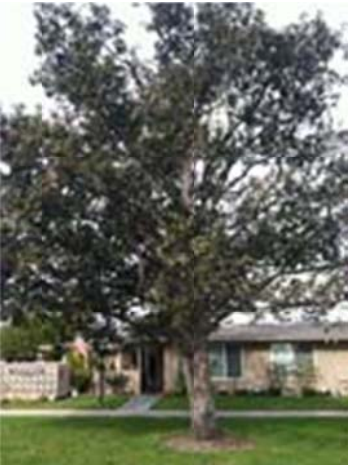
<p>Site 72 <i>Alnus rhombifolia</i> - White Alder</p> <p>This tree has good form, but it has a few crossing limbs. The lowest one, on the West side of the tree, should not be corrected because a pleach has already completed between it and the Western trunk. This pleach is a weak point in the structure of the tree, but removing the crossing branch will only turn this weak point into a decay site. In addition, there are several other branches in the tree that are lying across key scaffold branches. Those that have not pleached yet should be removed. There are some dead limbs in the canopy that should be removed, and the tree should be pruned for sidewalk clearance.</p> <p>Next Service: winter Priority: medium Maintenance: 45 min</p>

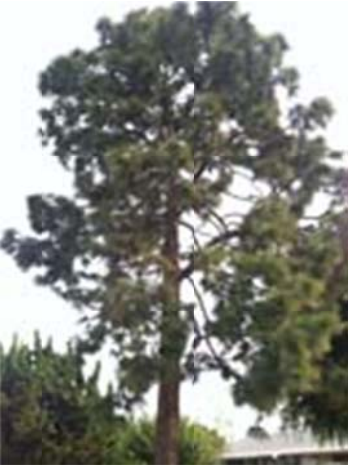
<p>Site 73 <i>Pinus canariensis</i> - Canary Island Pine</p> <p>This is an excellent specimen for this location. This tree has the potential to grow very tall. There are some dead branches in the upper canopy that should be removed before they self-prune. This tree is also beginning to compete with the nearby <i>Ficus</i> tree. A decision should be made about the future of the <i>Ficus</i> tree. If it is to be retained, then the lower fringe of the pine tree should be pruned back to give space. However, if the <i>Ficus</i> tree is going to be removed, then the pine tree should not be pruned back because it will fill up the space.</p> <p>Maintenance: 40 min. with climber Next Service: now Priority: medium</p>

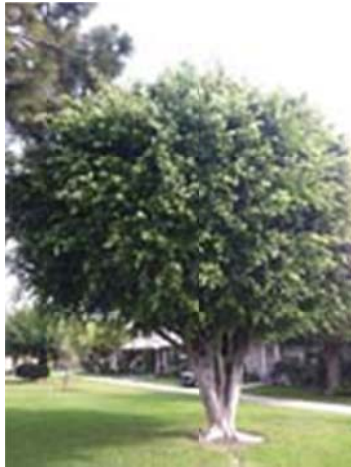
Site 74

This species is not an ideal choice for the landscape because of its aggressive roots. There is already evidence that roots have caused damage to the surrounding hard scape. There are some surface roots that have been damaged by passing lawnmowers. Many of the trunks are crossing each other and are pleaching together, limiting the tree's life. The *Ficus* tree is a fast grower, and it will need to be maintained heavily annually. The weeping fringe will need to be pruned back for head height clearance. The *Ficus* tree should be considered for removal.

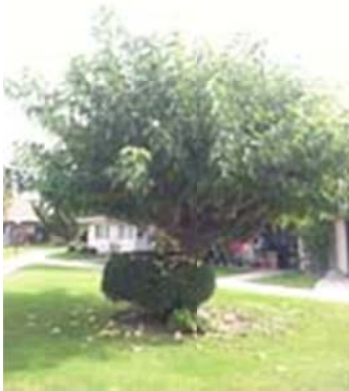
Site 78

This Mulberry tree has been pollarded many times in the past, and from these pollard points many new shoots have re-sprouted. These shoots are competing with each other for light and will develop into long, slender limbs with little lateral branching or branch taper. Over time, these structures will become susceptible to wind throw and failure because of their weak attach points. The structural armature of the tree can be retrained gradually over a period of 2-3 years.

Fruitless Mulberry is a fast-growing species that requires costly maintenance. Although the tree will have the potential to recover from this previous pruning, it should be recommended for removal and replacement to reduce the cost of maintaining the landscape.
